# Service Bulletin

Bulletin No.: 16-NA-318

**Subject:** Hard to Steer in Colder Temperatures and/or Knocking/Clicking Noise Heard

Brand:	Model:	Model Year:		VIN:		Engine:	Transmission:
		from	to	from	to		
Buick	Encore	2013	2017			All	All
Chevrolet	Trax	2013	2017			All	All

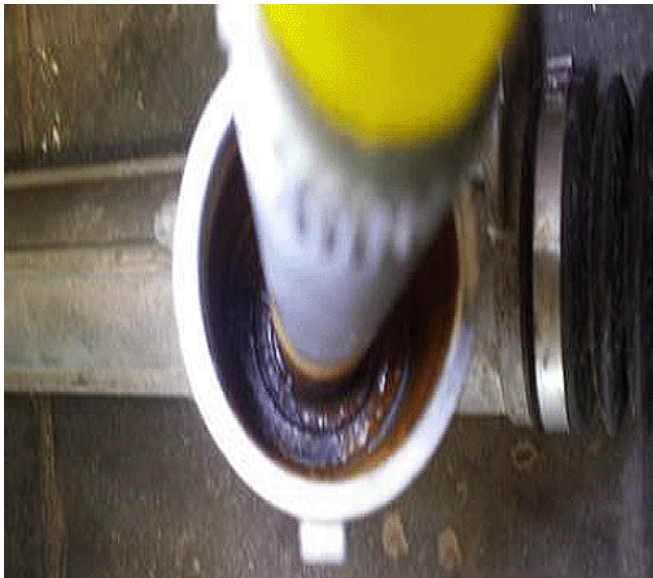
4355408

Check for water intrusion and corrosion at the power steering gear pinion housing. A small amount of rust spots are normal such as one or two small red rust spots.

If water intrusion and/or more than 1 or 2 rust spots is detected, replace both the intermediate steering shaft boots (seals) and the steering gear.
