Service Bulletin

Bulletin No.: 16-NA-370

Subject: Sunroof Rattle, Creak, Tick and/or Double Click Noise During Operation

Brand:	Model:	Model Year:		VIN:		Engine:	Transmission:
		from	to	from	to		
Cadillac	CT6	2016	2017			All	All

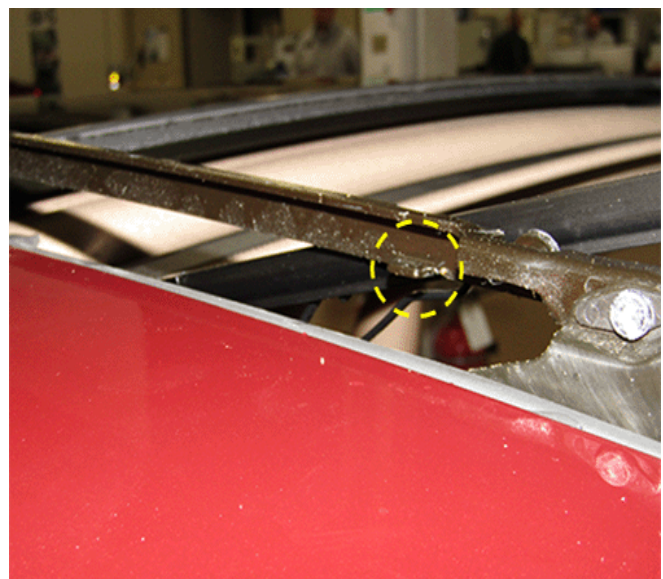
4622186

Note: The right side tab is shown circled in the graphic above. The front sunroof window was removed for illustration purposes only.

1. Open the front sunroof window enough to gain access to the tab which hangs down from the mechanism bracket, on each side of the sunroof. They are located approximately 30.5 mm (1.2 in) rearward of the front window screw.

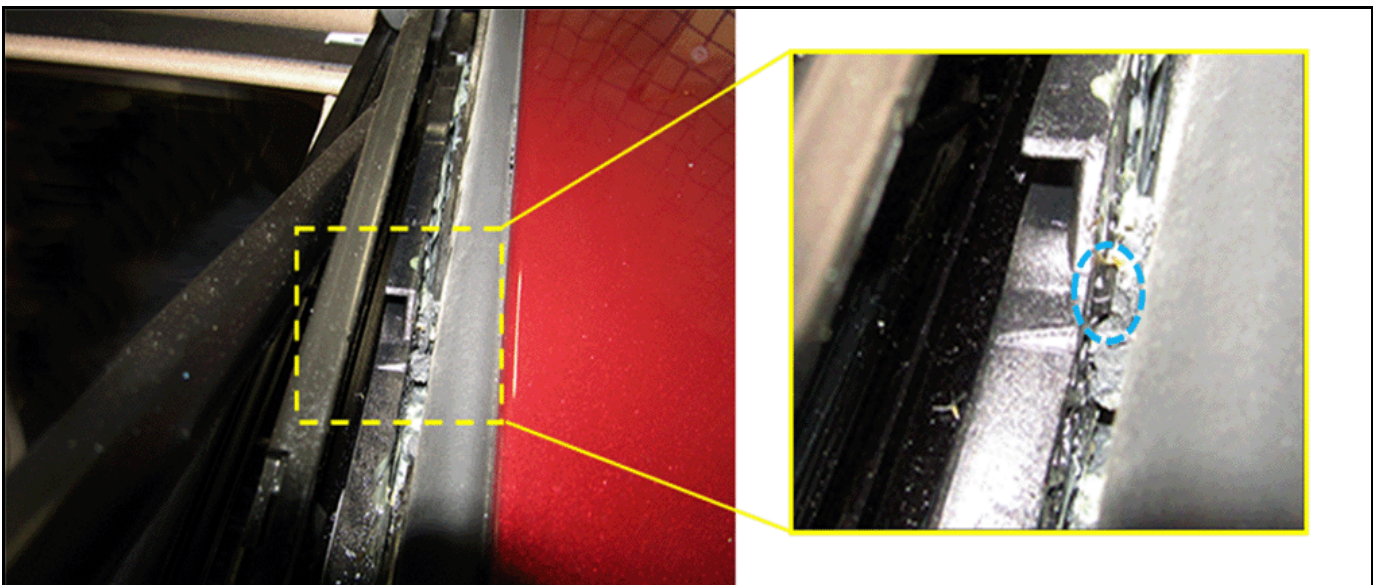
4622191

3. Locate the small “tail” extrusion on the rubber isolator on one side of the sunroof.

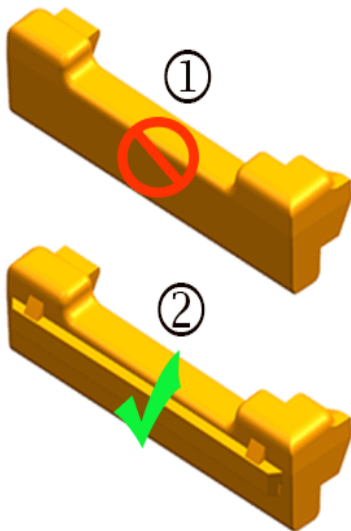
4622225

Note: To improve performance, a more robust second design of the sunroof inner middle seal has been implemented. The first graphic above shows the difference between the first (1) and second (2) design level.

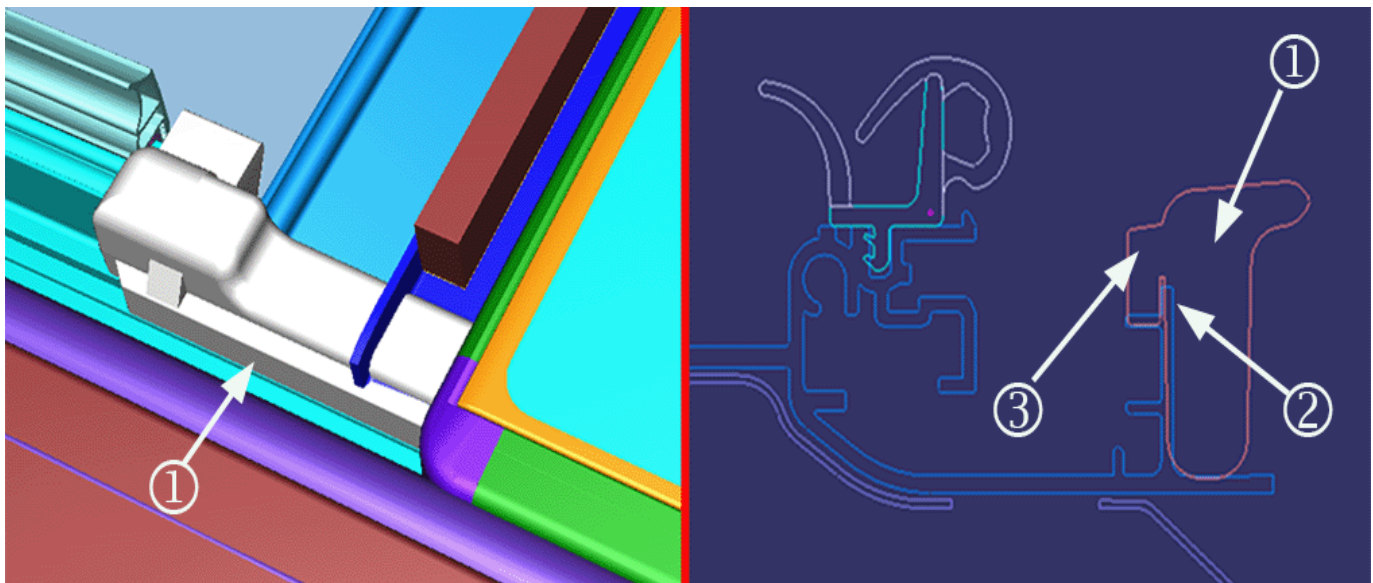
4622229

Note: The second graphic shows an illustration and cross-section of the correct positioning of the second design seal (1). The added portion of the seal (3) is intended to cap-over the guide flange (2) and isolate the drain channel from contact with the guide flange.

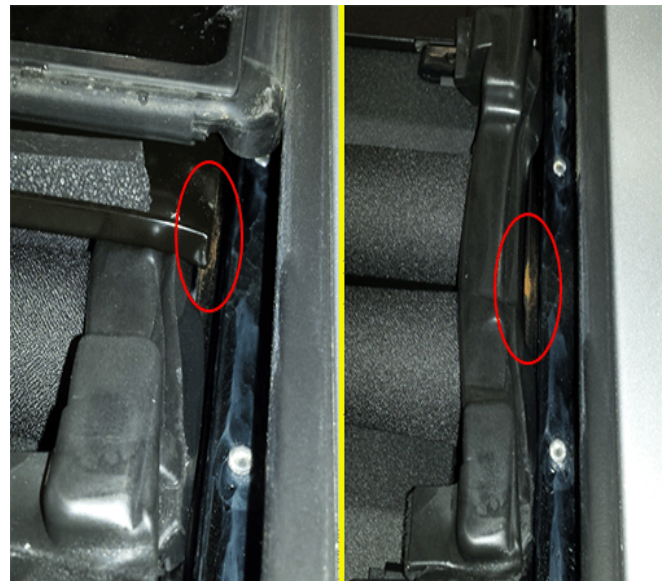
4622231

⇒ Inspect the seals for evidence of them being mis-positioned, or rolled out of position on either or both sides. If this condition exists and the guide flange is exposed, there will likely be corrosion evident (shown circled above), due to the metal to metal contact of drain channel to the guide. If exposure of the guide flange or corrosion is evident, continue to step #12.

11. Inspect the sunroof window inner middle seals on both sides of the sunroof. We first want to ensure the vehicle has the new second design seals, and if so, want to make sure the seals are properly positioned.

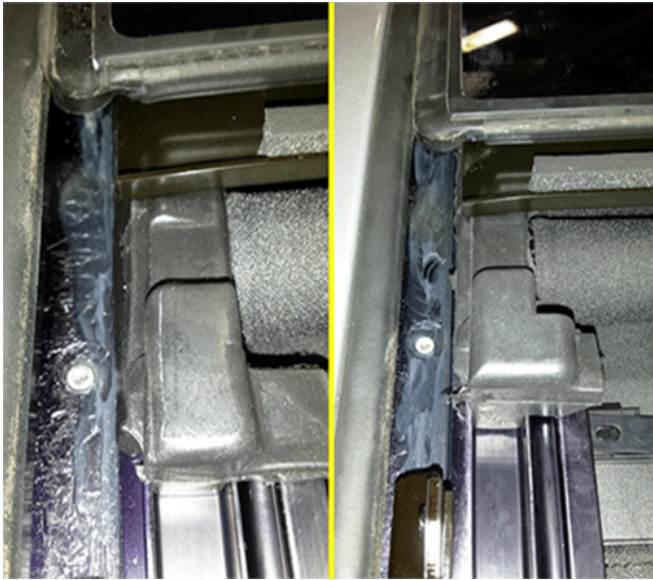
4622234

⇒ The graphic above shows examples of proper seal installation. Some slight roll of the seal is acceptable as long as the drain channel is completely isolated from the guide flange. If they are properly positioned on both sides, move ahead to step #13.

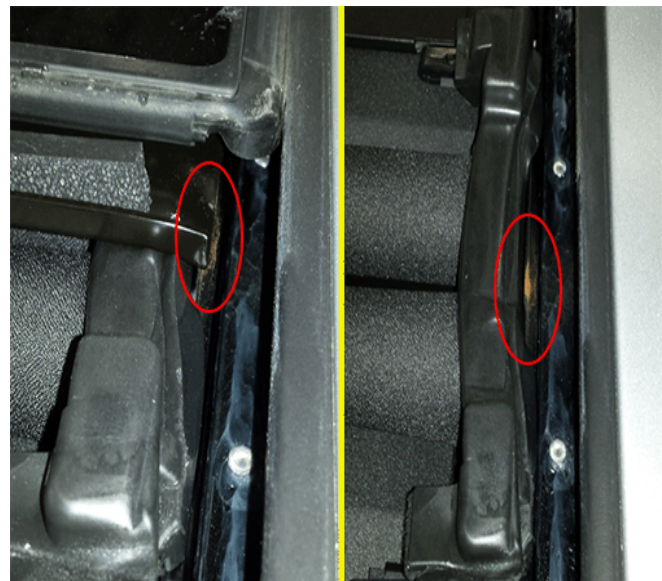
4622231

⇒ Inspect the seals for evidence of them being mis-positioned, or rolled out of position on either or both sides. If this condition exists and the guide flange is exposed, there will likely be corrosion evident (shown circled above), due to the metal to metal contact of drain channel to the guide. If exposure of the guide flange or corrosion is evident, continue to step #16.

15. Open the front sunroof window and inspect the sunroof window inner middle seals on both sides of the sunroof. We first want to ensure the vehicle has the new second design seals, and if so, want to make sure the seals are properly positioned.

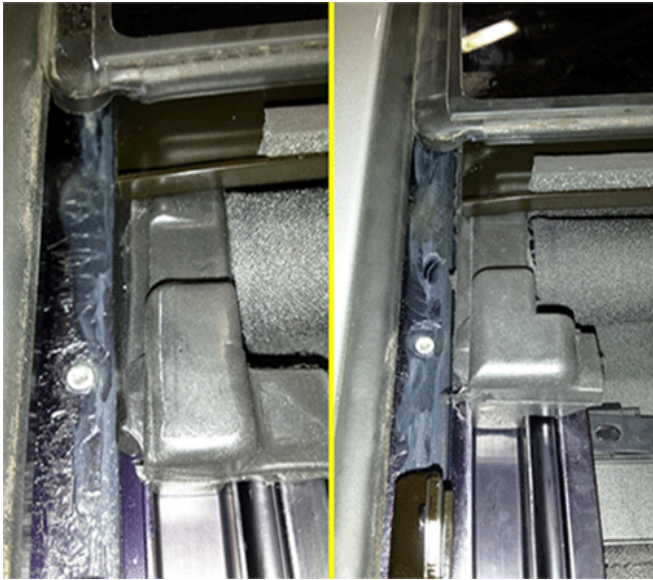
4622234

⇒ The graphic above shows examples of proper seal installation. Some slight roll of the seal is acceptable as long as the drain channel is completely isolated from the guide flange. If they are properly positioned on both sides, move ahead to step #17.
