Service Bulletin

Bulletin No.: 16-NA-405

Subject: Poor Engine Performance in Extremely Cold Weather Conditions, PCV Bypass Hose and Charge Air Cooler Icing for LUV Engines, Malfunction Indicator Lamp (MIL) Illuminated - DTC P0299, P0236, P2227, P00C7 Set

Brand:	Model:	Model Year:		VIN:		Engine:	Transmission:
		from	to	from	to		
Buick	Encore	2013	2018			1.4L (LUV)	
Chevrolet	Trax

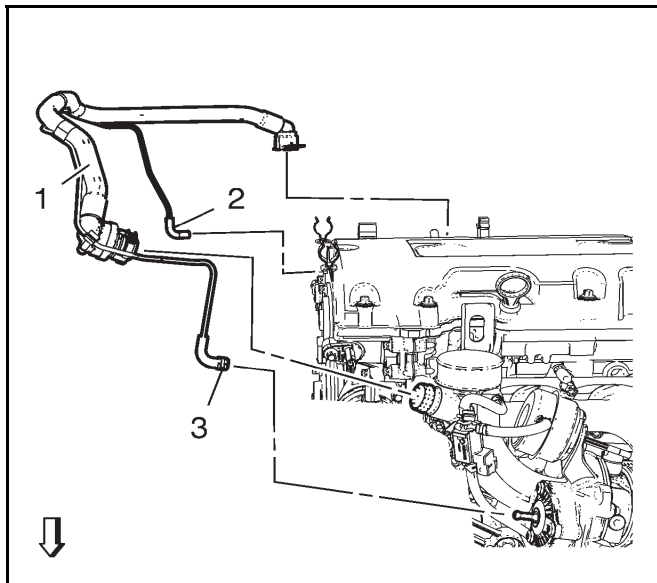
2191937

Note: Original PCV pipe with vacuum line attached removed from vehicle for illustrative purposes **ONLY**.
