Service Bulletin

Bulletin No.: 18-NA-063

Subject: Multiple Electrical Issues, Dead Battery, Start/Stop Inoperative, Instrument Cluster and Switch Backlighting Remain Illuminated

Brand:	Model:	Model Year:		VIN:		Engine:	Transmission:
		from	to	from	to		
Cadillac	XT5	2017	2017			All	All
GMC	Acadia (VIN N)

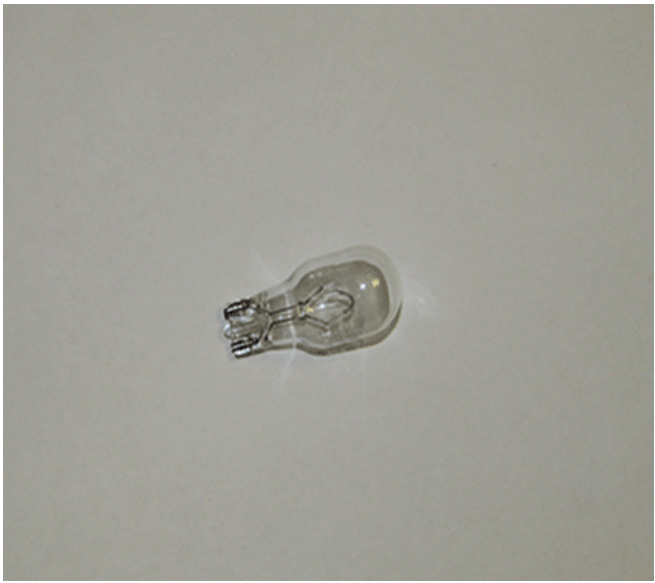
</div> <p style="text-align: right; font-size: small;">4977973</p> <p>The cause of the condition may be that the wrong bulbs may have been installed in the backup lamps. Incandescent bulbs (example shown above) should have been used, but LED's may have been incorrectly installed in their place.</p> <p>Note: The BCM evaluates the Reverse Lamp circuit to determine bulb outages by applying and monitoring a low voltage signal. Because LED lamps have different electrical properties than Incandescent bulbs, the circuit does not operate as expected. The BCM is calibrated for incandescent lamps and may stay awake after key off, if LED's are used. The BCM will continuously monitor the circuit, resulting in the symptoms identified above.</p>

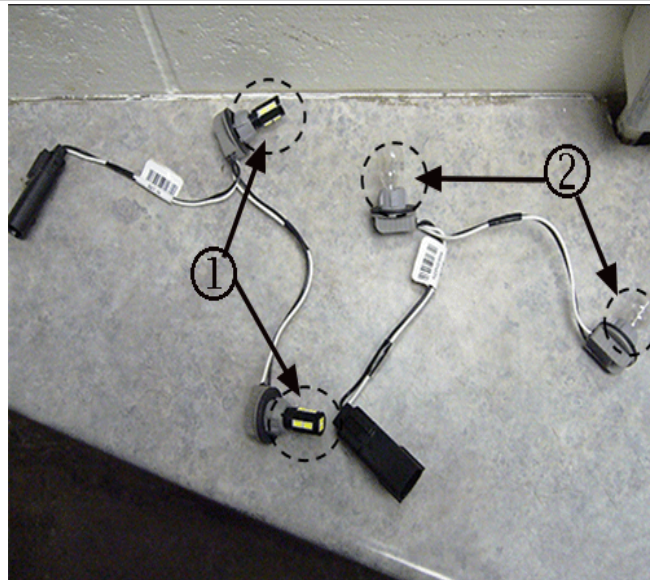
4977978

- If the bulbs are found to be LED (1), the incorrect bulbs have been used and they need to be replaced with Incandescent bulbs.
- If the bulbs are found to be the proper incandescent bulbs (2), refer to SI for further diagnostic recommendations.

On vehicles that exhibit the above conditions or other electrical abnormalities, check the bulbs in the back up lamp locations.

For backup bulb replacement, refer to the appropriate *Backup Bulb Replacement* procedure below.
