Service Bulletin

Bulletin No.: 18-NA-066

Subject: Back-Up Camera Image Distorted, Rolling, Flickering, Black, Red and Blue Screen

Brand:	Model:	Model Year:		VIN:		Engine:	Transmission:
		from	to	from	to		
Chevrolet	Sonic	2018	2018

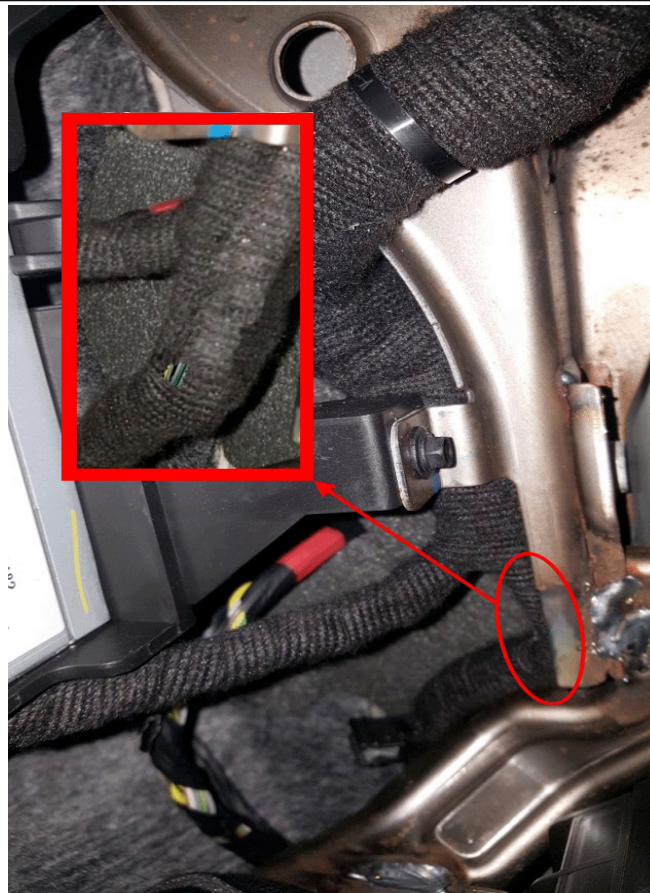
4991385

This condition may be caused by the instrument panel (IP) wiring harness, located on the passenger side, being pinched between the IP carrier and the A-pillar.

Remove the side IP trim cover, and with a suitable light, inspect the harness for being pinched.

If the harness is found to be pinched, repair the harness as needed.

Refer to *Wire to Wire Repair - Instrument Panel and Console* in SI.
