Service Bulletin

Bulletin No.: 18-NA-066

Subject: Back-Up Camera Image Distorted, Rolling, Flickering, Black, Red and Blue Screen

Brand:	Model:	Model Year:		VIN:		Engine:	Transmission:
		from	to	from	to		
Chevrolet	Sonic	2017	2018

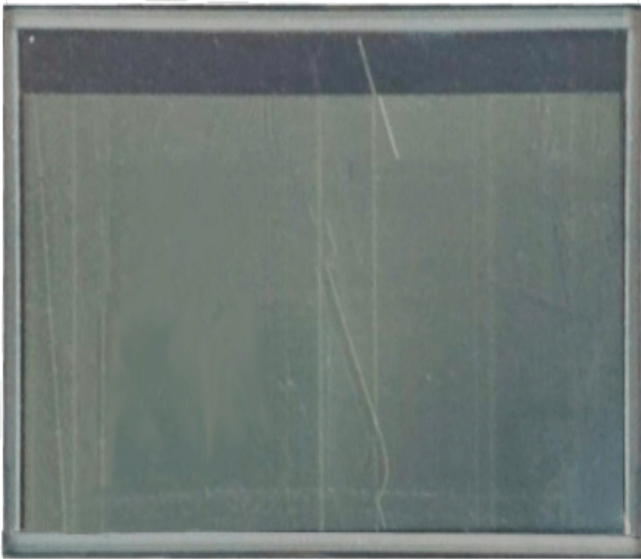
<p style="text-align: right;">4991409</p> <ul style="list-style-type: none"> • Distortion • Flickering • Rolling

This condition may be caused by the instrument panel (IP) wiring harness, located on the passenger side, being pinched between the IP carrier and the A-pillar.

Remove the side IP trim cover, and with a suitable light, inspect the harness for being pinched.

If the harness is found to be pinched, repair the harness as needed.

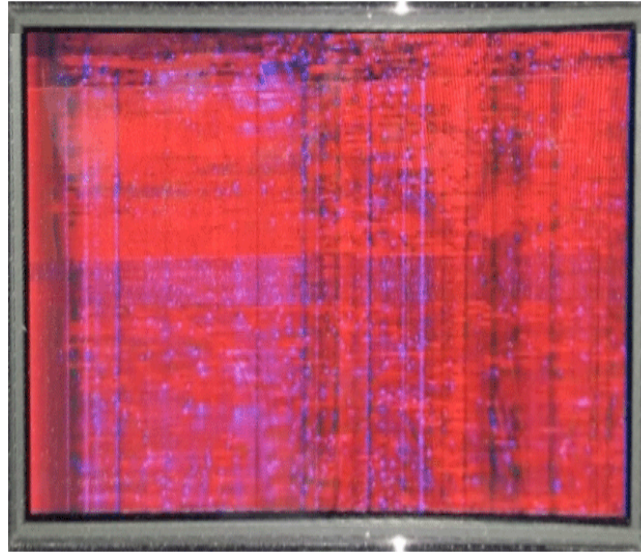
4991400

- Red and blue screen
- Black screen
