Service Bulletin

Bulletin No.: 18-NA-073

Subject: Repair Guidelines for Engine Component Wear

Brand:	Model:	Model Year:		VIN:		Engine:	Transmission:
		from	to	from	to		
GM Passenger Cars and Trucks		2015	2019	All	All	All	—

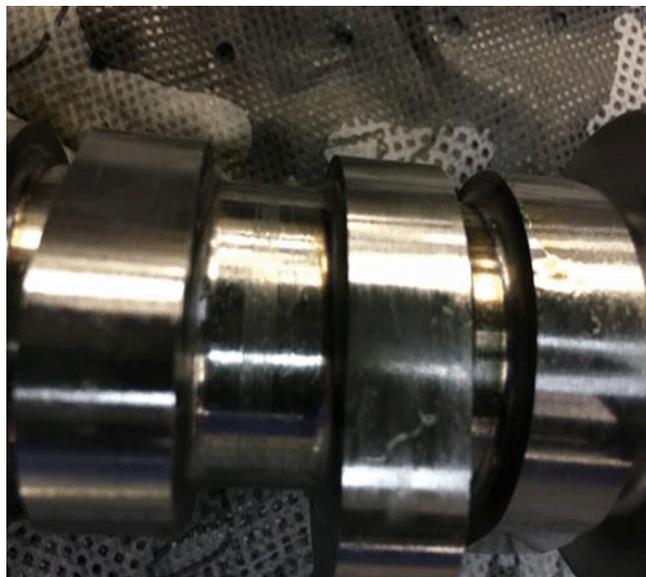
4994025

Example of minor scratching/scoring visible on camshaft lobes and/or camshaft bearing journals. In this example, the scored components can be replaced without need for engine assembly replacement.

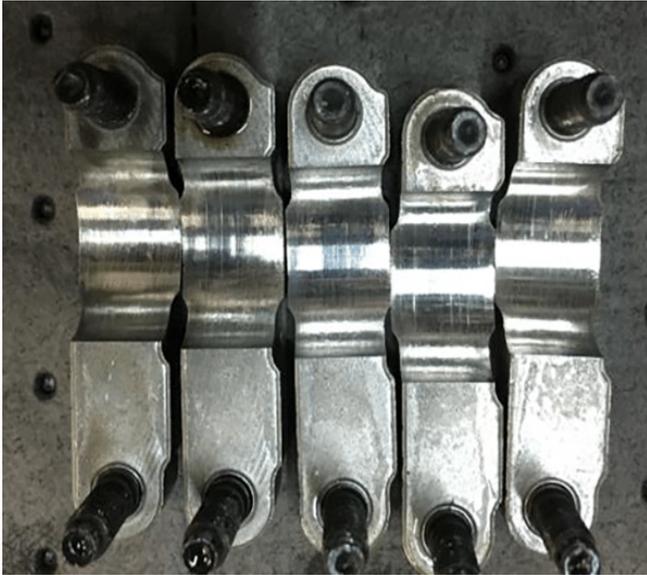
4991477

Example of minor scratching/scoring visible on camshaft bearing caps. In this example, the scored components can be replaced without need for engine assembly replacement.

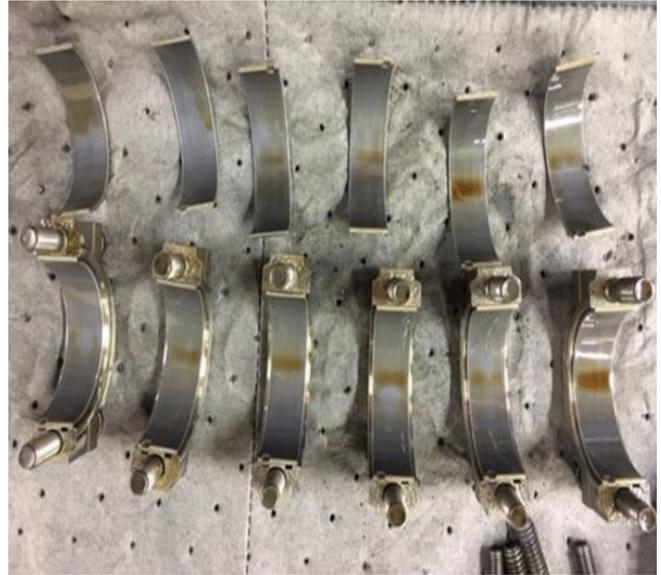
4992132

Example of minor scratching/scoring visible on connecting rod bearings. In this example, the scored components can be replaced without need for engine assembly replacement.

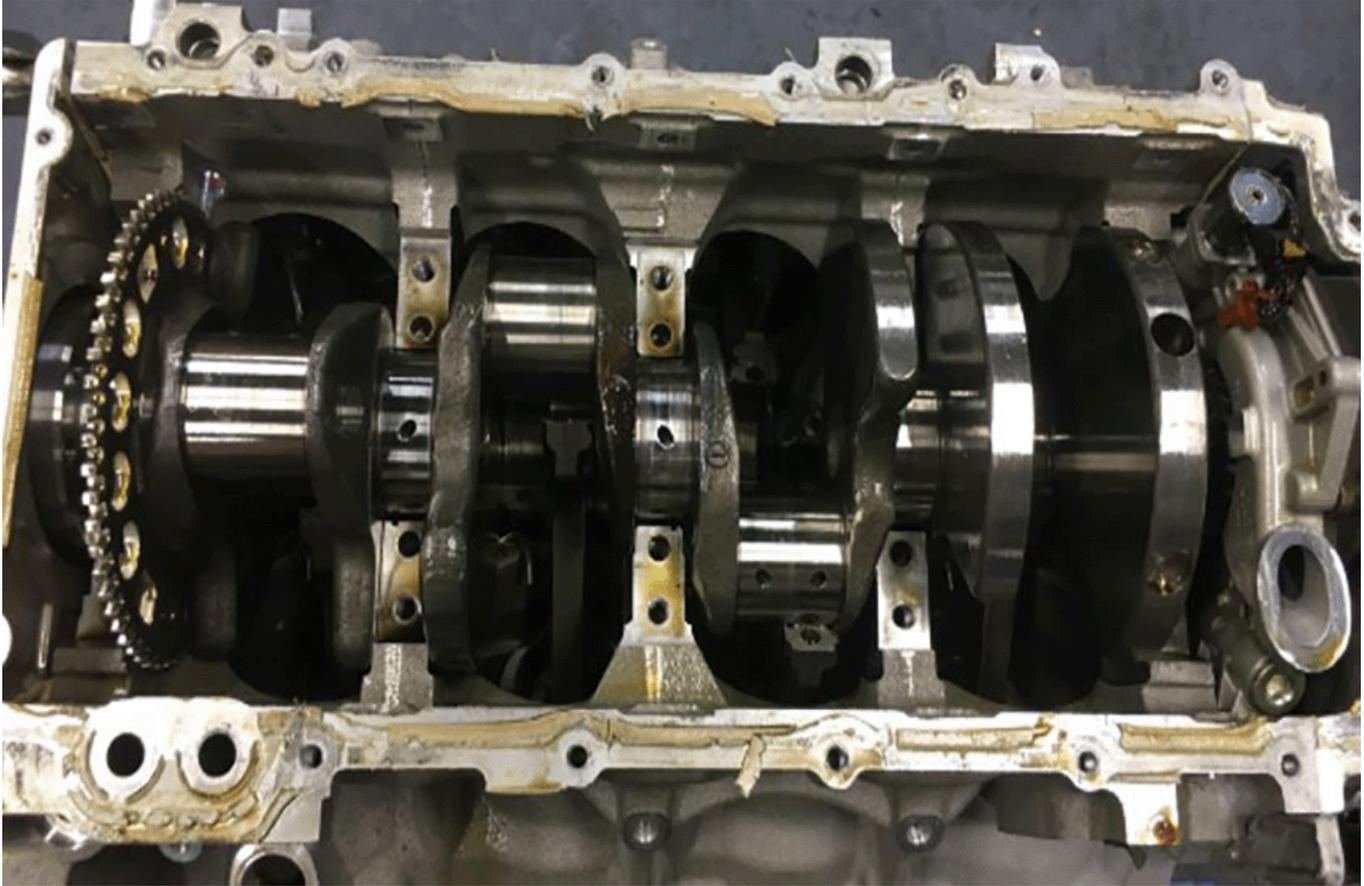
4990880

Example of minor scratching/scoring visible on crankshaft. In this example, the scored components can be replaced without need for engine assembly replacement.

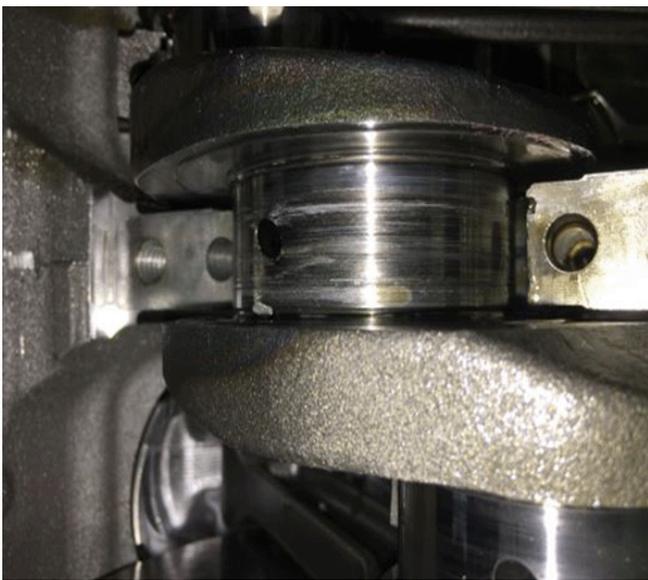
4986379

Example of minor scratching/scoring visible on crankshaft. In this example, the scored components can be replaced without need for engine assembly replacement.

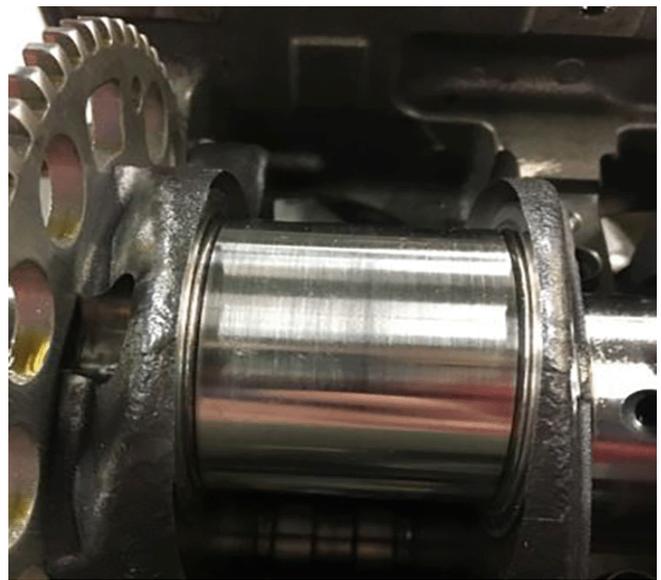
4990640

Example of minor scratching/scoring visible on crankshaft. In this example, the scored components can be replaced without need for engine assembly replacement.

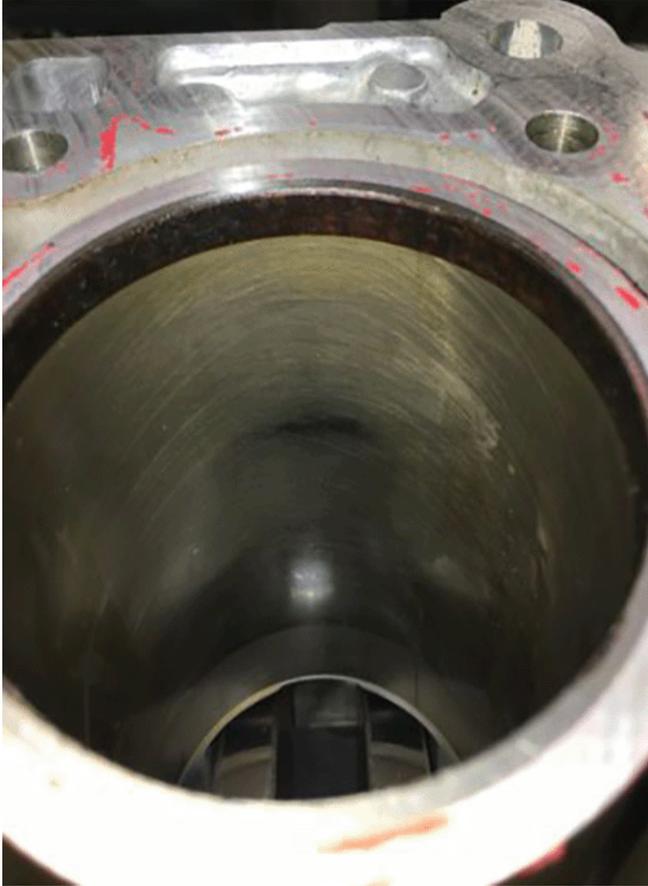
4992739

Example of minor scratching/scoring visible on cylinder wall. In this example, if you cannot catch a toothpick or fingernail on the scratch, the cylinder bore / engine block does not require replacement. If piston is slightly scored, the scored piston can be replaced without need for engine assembly replacement. (additional reference: PIP5163)

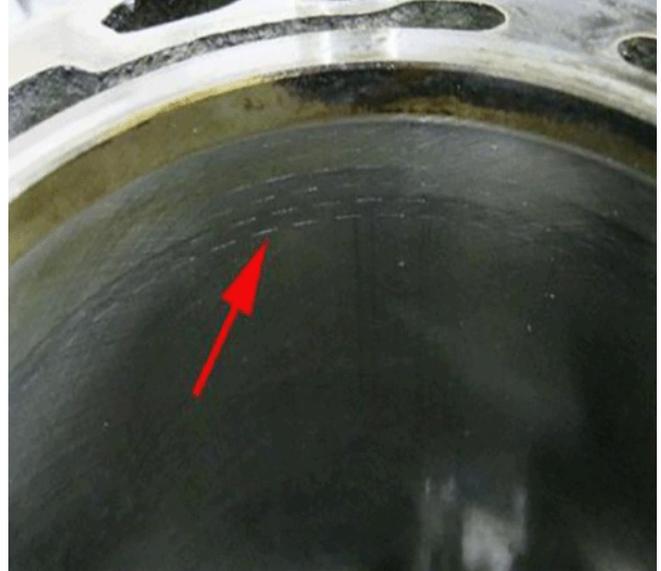
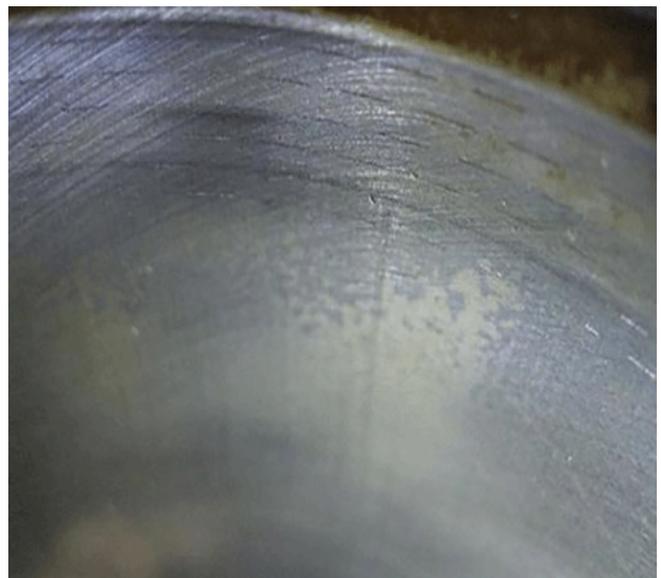
Some technicians may be replacing entire engine assemblies due to marks found at the top of the cylinder bore. These marks are considered normal and are left as a result of a manufacturing laser honing process. **DO NOT** replace the cylinder block or the engine for these normal laser honing marks. (refer to PI0725)

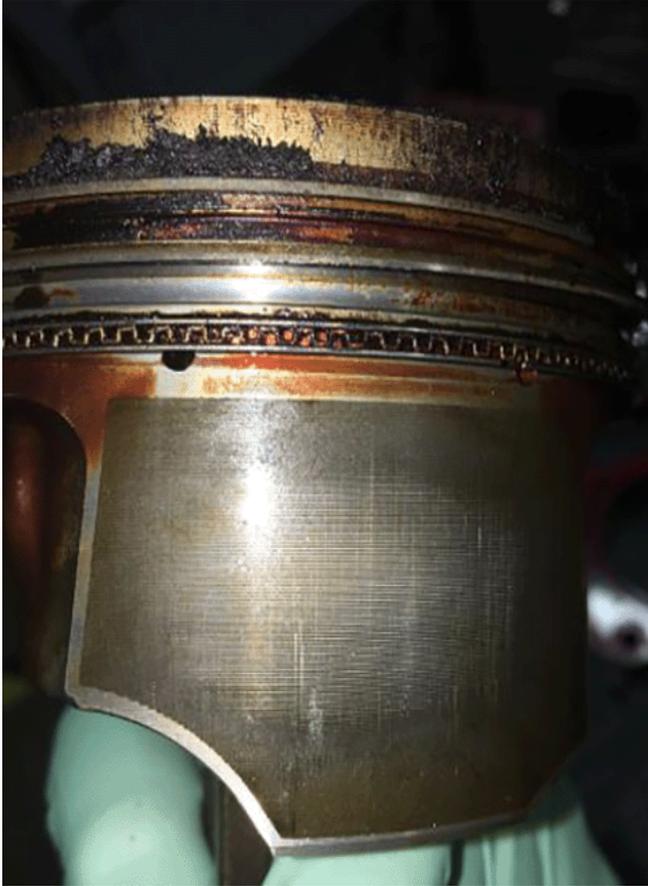
4992916

Example of minor scratching/scoring visible on piston. In this example, inspect for broken and/or stuck rings and piston ring lands and cylinder wall for damage. If no cylinder wall damage or other significant damage, components can be replaced without requiring an engine assembly replacement.

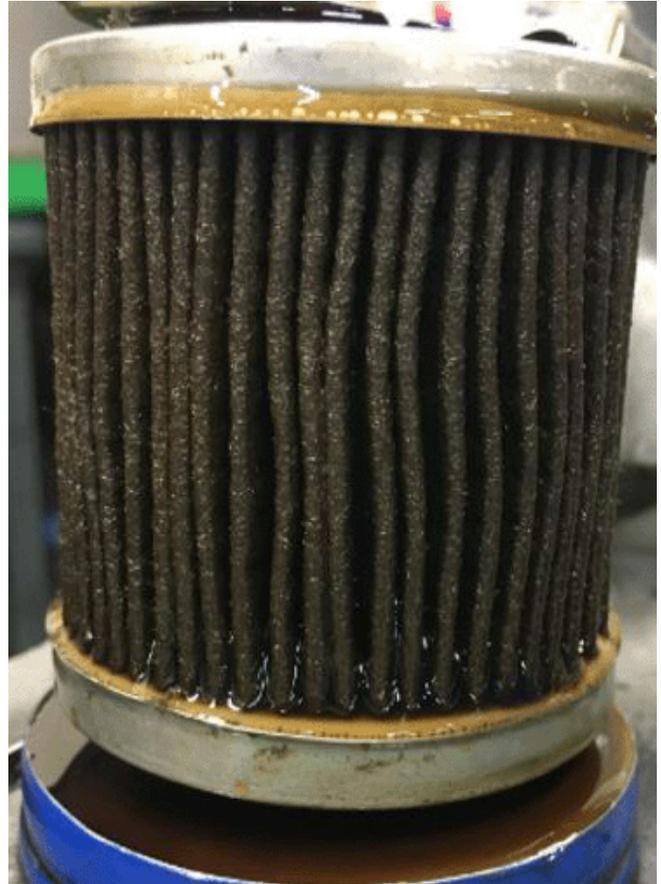
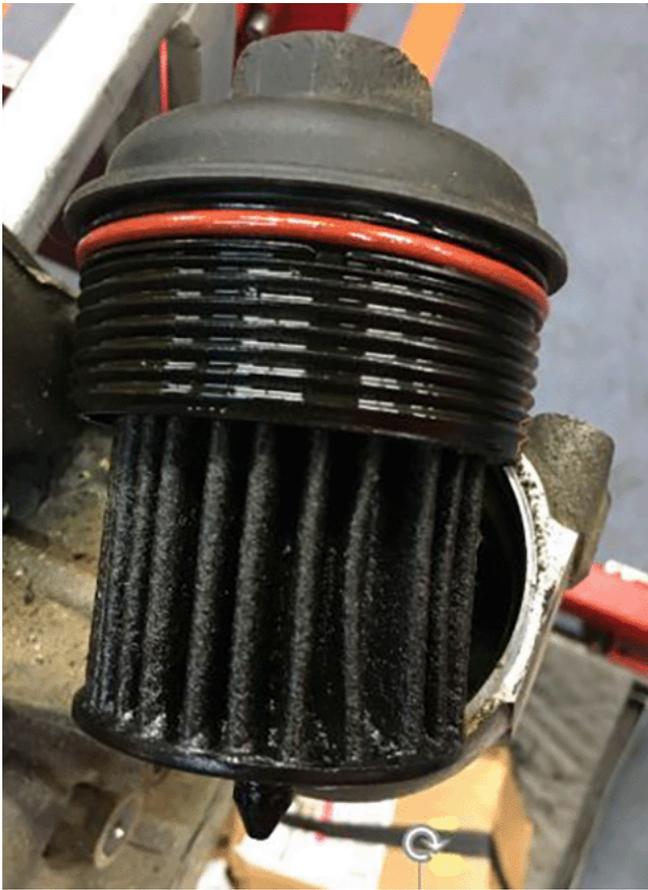
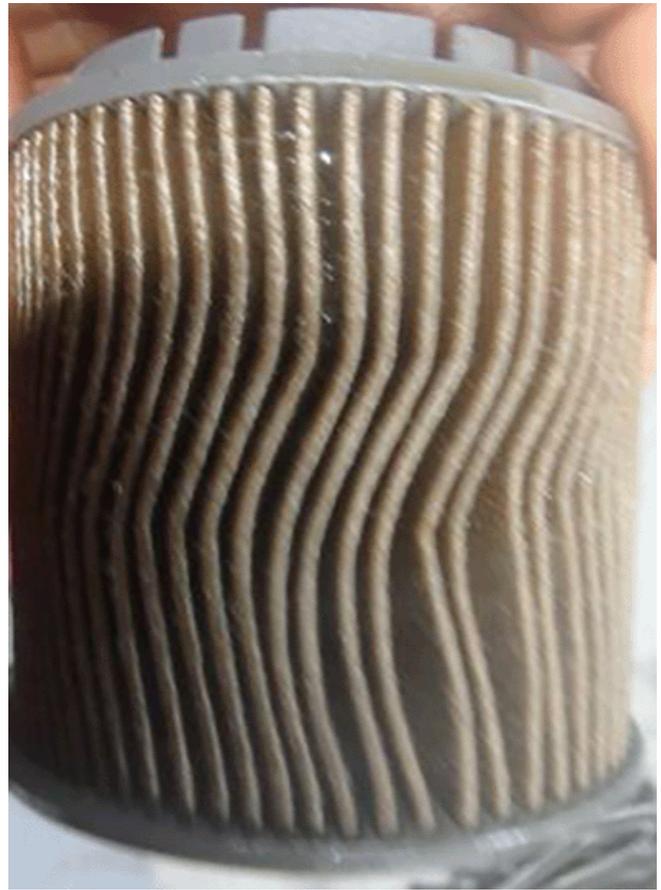
Shown are oil filter pleats with visible metal particles. In this example, minimal amounts of metal particles are visible on oil filter pleats and should not pose a concern.

If excessive amounts of metal particles are observed or if there is evidence of damaged oil filter pleats, then unfiltered oil with bearing debris may have been pumped into the oil lubrication galleries, throughout the engine. This will require further inspection to confirm degree of contamination and appropriate repair direction. (Refer to PIP5216 for HFV6 Gen 1 and Gen 2)

In cases involving suspected bearing failure, remove and inspect the oil filter for excessive debris and damaged pleats. Use the inspection as an indicator of the amount of material that is displaced through the engine and lubrication circuits. This may help to avoid unnecessary engine removal.
