Service Bulletin

Bulletin No.: 18-NA-083

Subject: Service Transmission Message Displayed On Drivers Information Center (DIC), Malfunction Indicator Lamp Illuminated (MIL) - DTCs P073D, P073E, P07E4, P07E5, and/or P1769 Set

Brand:	Model:	Model Year:		VIN:		Engine:	Transmission:
		from	to	from	to		
Buick	Lacrosse	2017	2017				MRC
Cadillac	XT5	2017	2018

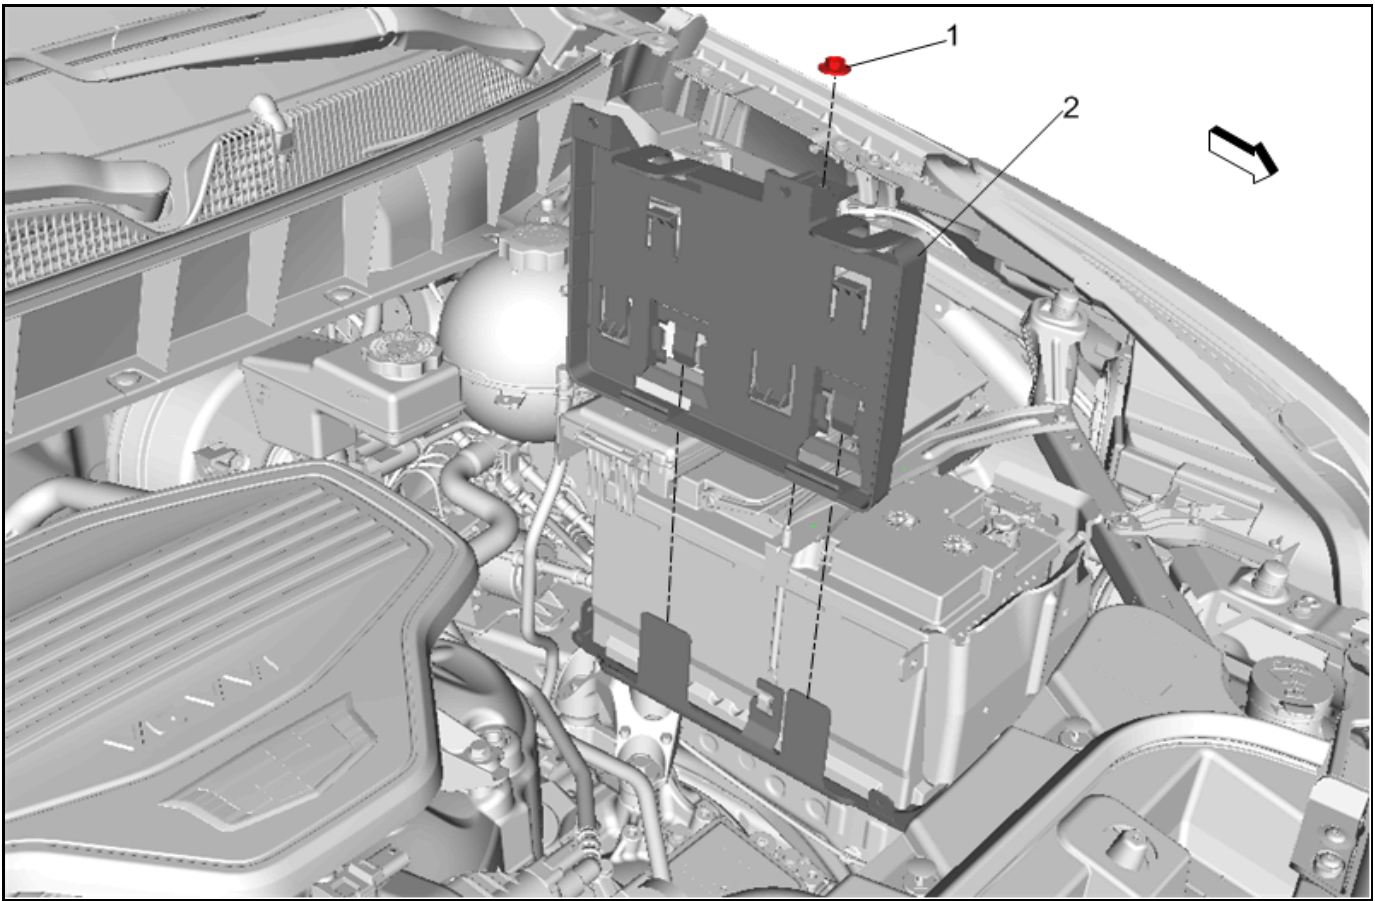
4290995

3. For the XT5 vehicles:

- 3.1. Without disconnecting the electrical connectors, detach the ECM from the bracket assembly and position aside.
- 3.2. Remove the ECM bracket (2).
- 3.3. Proceed to step 5.

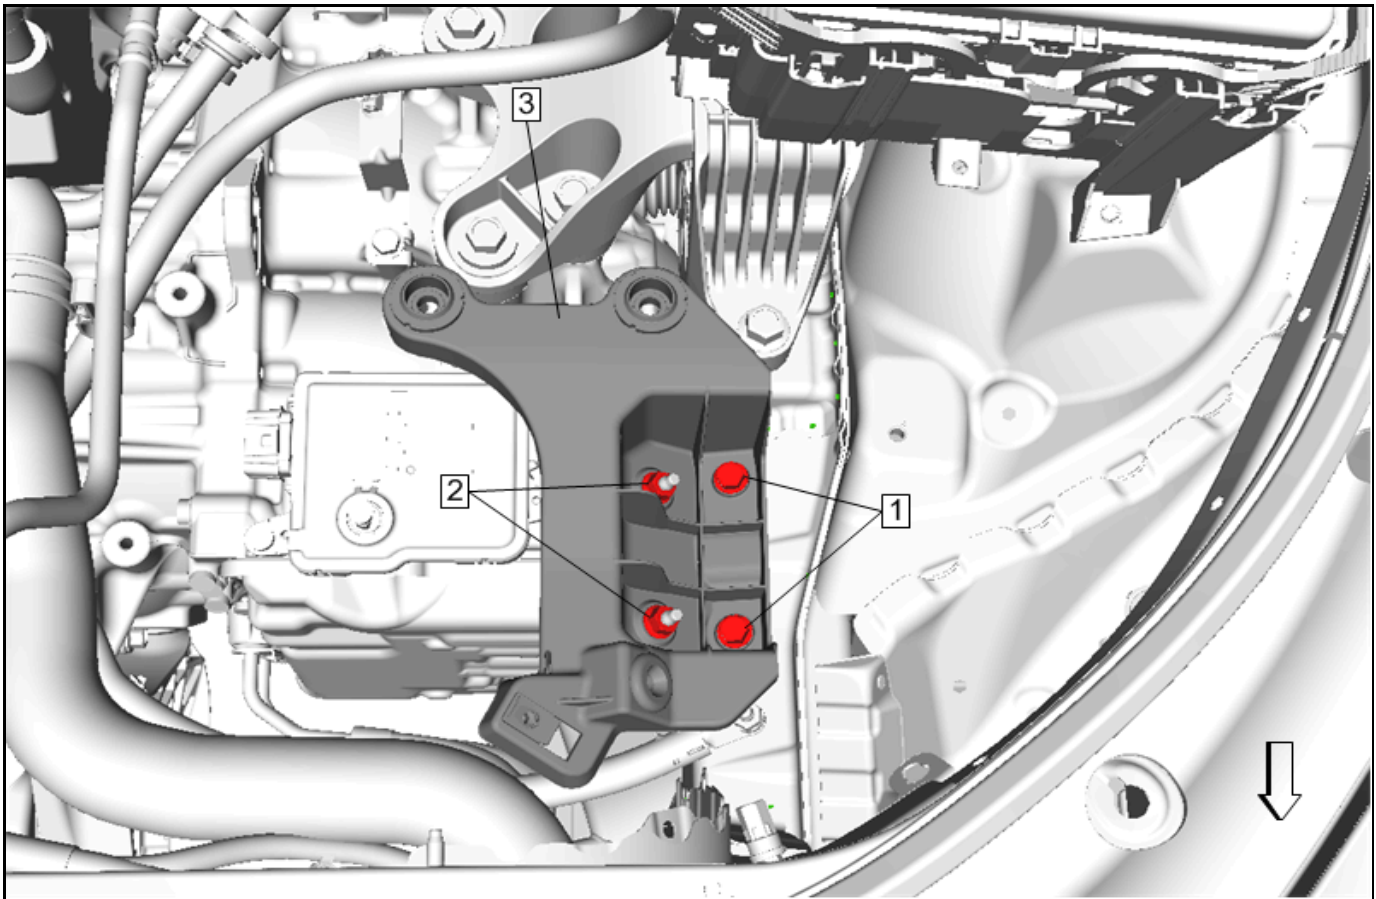
4451509

4. For the Lacrosse vehicles:

- 4.1. Remove the Air Cleaner Housing assembly. Refer to Air Cleaner Assembly Replacement in SI.
- 4.2. Remove the bolt that secures the intake air duct to the core support.
- 4.3. Remove the Air Cleaner Bracket (3).

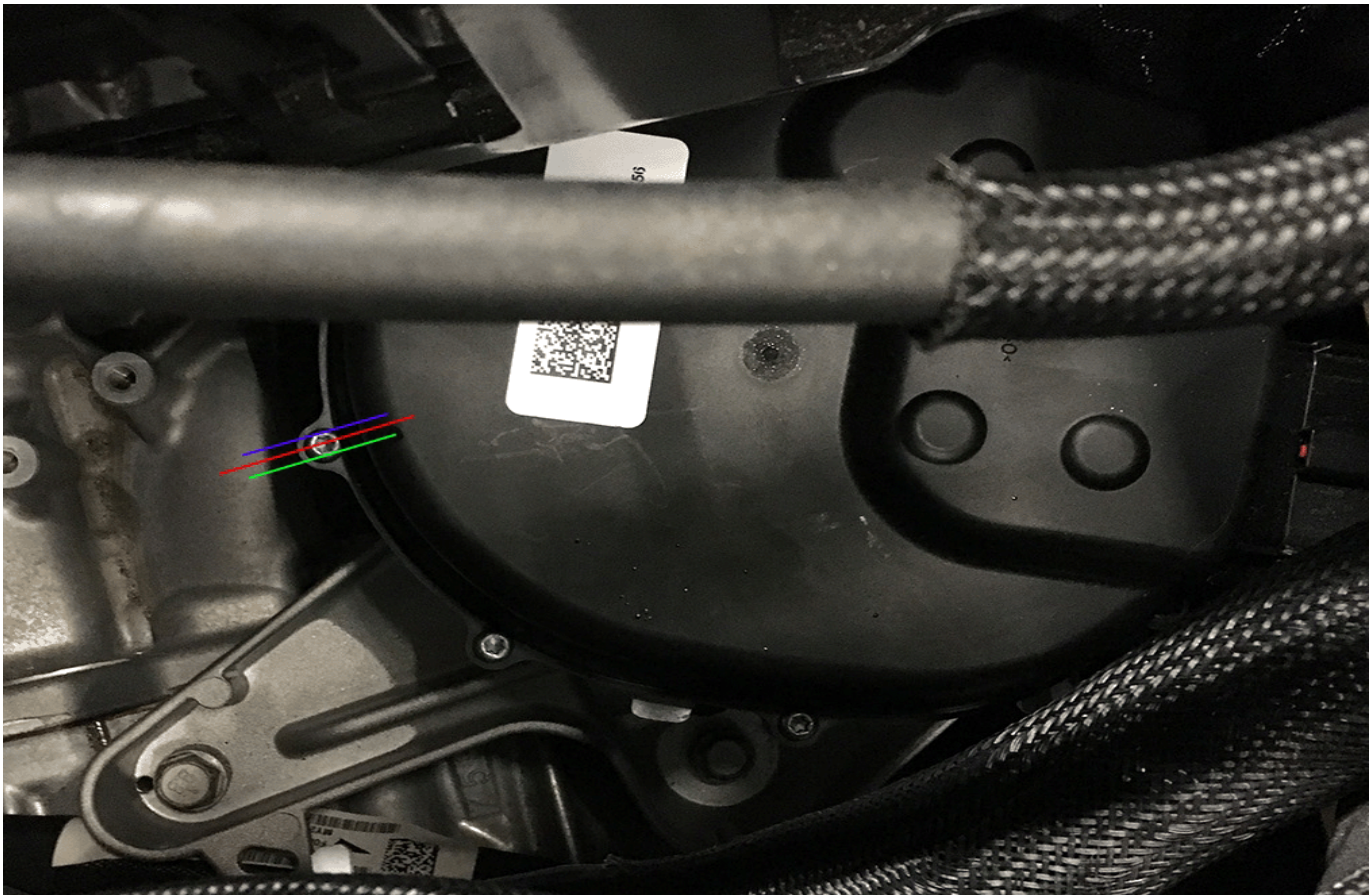
4997865

Note: The turning radius of the module will be very slight when centering.

6. Rotate the automatic transmission range selector actuator hardware module;
 - 6.1. Rotate clockwise until right lock position, shown with a blue line.
 - 6.2. Rotate counterclockwise until left lock position, shown with a green line.
 - 6.3. Rotate clockwise until it is centered between both full lock positions, shown with a red line.
7. While holding the automatic transmission range selector actuator hardware module with one hand, tighten hardware module bolts to prevent the actuator from moving from the center position.
8. Torque the automatic transmission range selector actuator hardware module bolts.
 - ⇒ Refer to Fastener Specifications in SI.
