# Service Bulletin

Bulletin No.: 17-NA-394

**Subject: Squeak, Clunking Type Noise Heard From Rear of Vehicle**

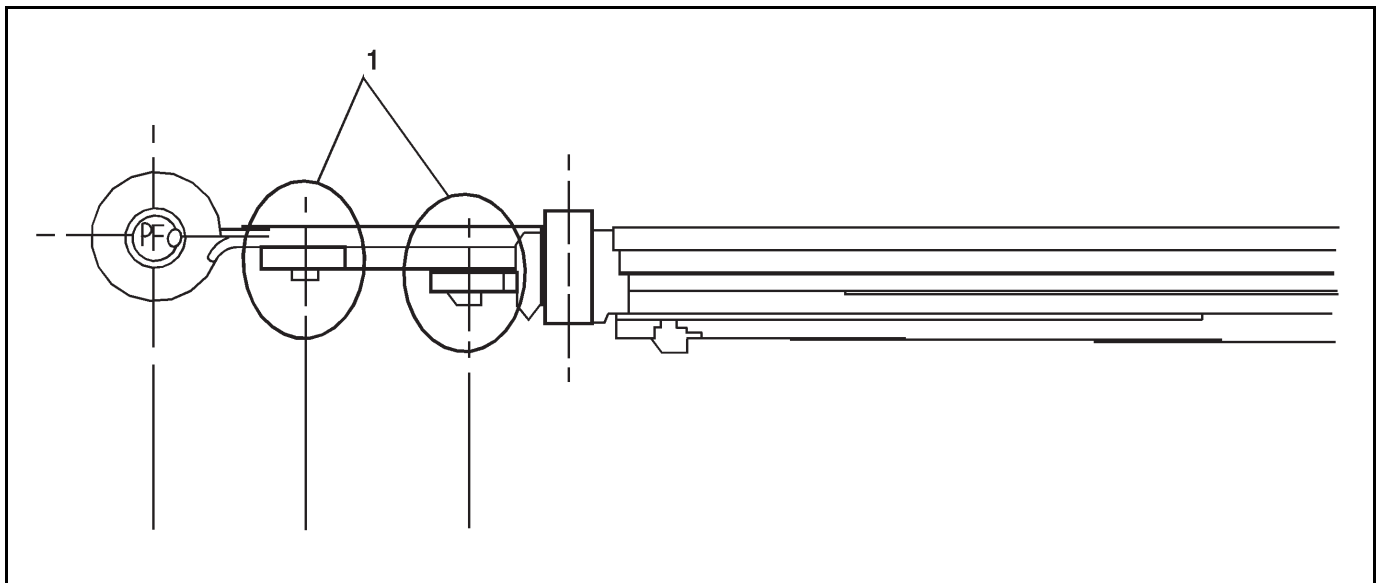
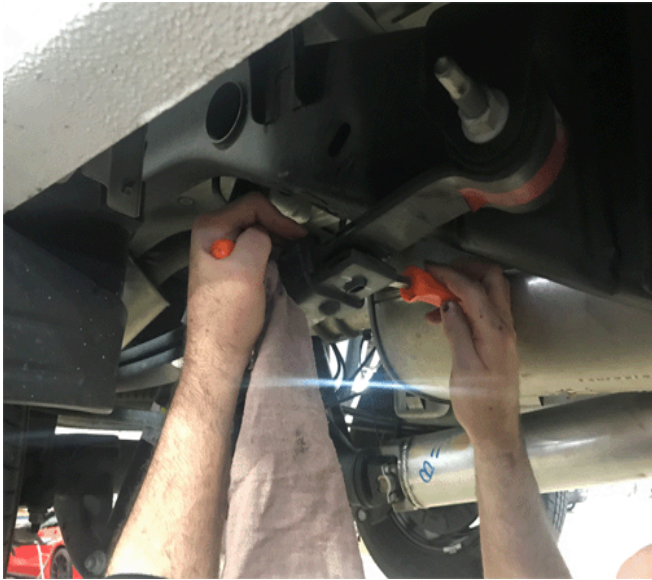
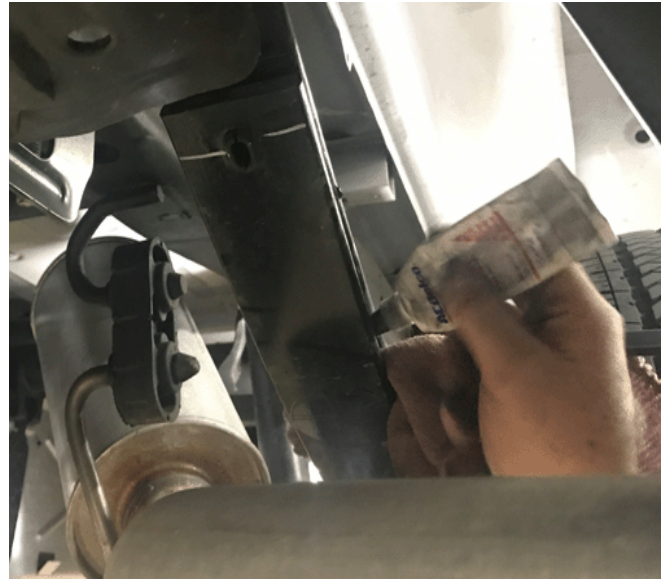
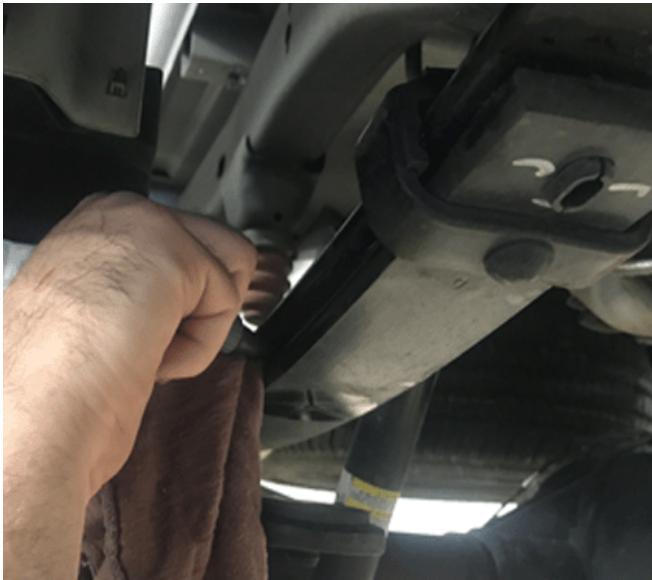
| <b>Condition 1</b> | Some customers may comment on a squeak type noise heard from the rear of the vehicle.<br>Upon further investigation, the technician may diagnose the noise is coming from the rear suspension leaf spring area. |
| <b>Cause</b> | These conditions may due to debris getting between the leaf springs. |

5. Apply a liberal amount of grease, P/N 19356408 (in Canada, use P/N 19356409), both underneath and on top of the front and rear tip inserts for the #2 and #3 leaves, as indicated above. A screwdriver can be used to gently pry up the leaf; however, a rag around the screwdriver must be used to prevent damage to the leaf. Use a flat-bladed tool, such as a gasket scraper or a brush to properly distribute the grease at least 6 inches from each end of the leaf.
6. Lower the vehicle to the ground and test drive to verify the repair.

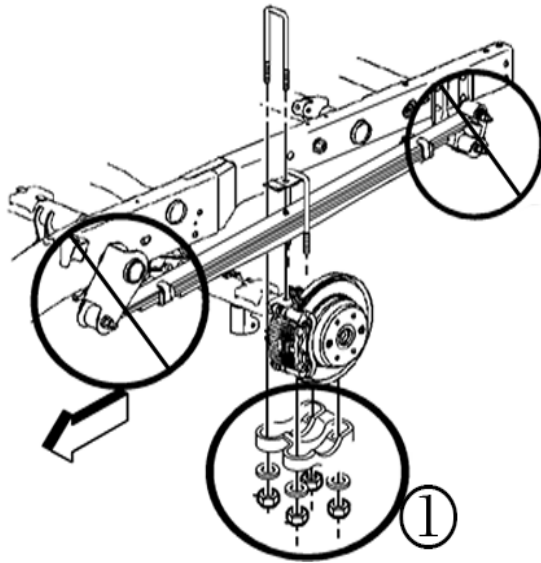
4966874

| <b>Condition 2</b> | Some customers may comment on a clunking type noise heard from the rear of the vehicle.<br>Upon further investigation, the technician may diagnose the noise is coming from the rear suspension leaf spring area. |

2. Loosen the left leaf spring anchor plate U-bolts (1).
3. Re-torque the anchor plate U-bolts (1). Refer to SI for torque specifications.
