# Service Bulletin

Bulletin No.: 18-NA-040

**Subject:** Noise Originating from Front of Vehicle while Driving or Turning Over Bumps

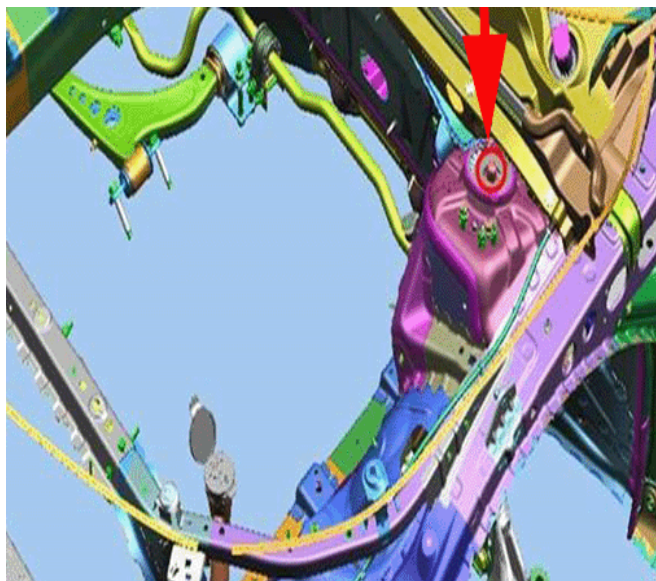
4960668

| Condition | Some customers may comment on a noise originating from the front of the vehicle when driving or when turning over a rough surface. |
| Cause | This may be due to the front strut upper nut not being torqued to specification. |

| Correction | Before replacing any front suspension part for noise, check the upper strut nut for the proper tightening specification of 85 N•m (63 lb ft). |
