Service Bulletin

Bulletin No.: 18-NA-043

Subject: Clicking Noise from Front of Vehicle with Wheels Straight Ahead on Acceleration Tip In/Tip Out or While Turning at Low Speeds

Brand:	Model:	Model Year:		VIN:		Engine:	Transmission:
		from	to	from	to		
Buick	Enclave	2017	2018			All	All
Cadillac	XT5	2017	2018			All	All
Chevrolet	Traverse	2017	2018			All	All
GMC	Acadia	2017	2018			All	All

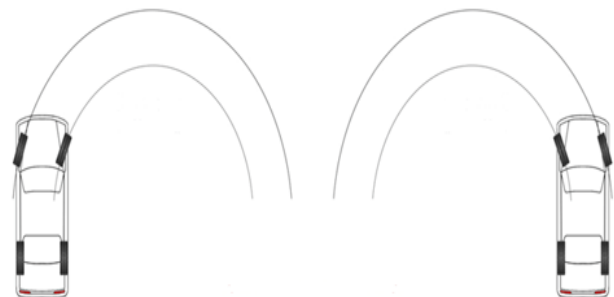
4954772

How to Determine if Wheel to Rotor Interface Click Noise is Present

1. Ensure you have an area where a full turn circle or a figure 8 can be achieved.
2. Ensure surface to be driven provides a good tire grip.

Note: Sandy surface may let tires slide reducing loading.

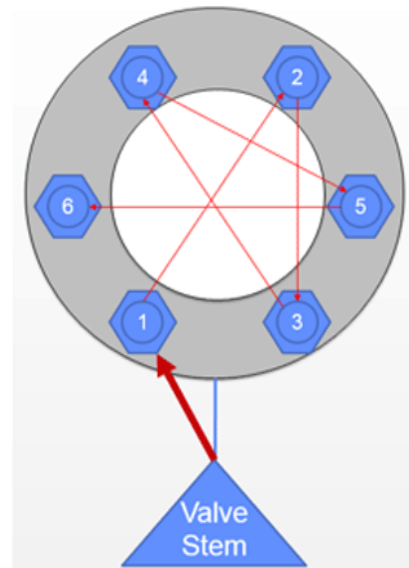
4954774

Torque Check Procedure

1. Ensure you have the vehicle on the ground, set in park, and with the Brake Park applied.
2. Torque check should be done with a calibrated torque wrench in the tightening direction.
3. Set tool to Nm units.
4. Position yourself in a comfortable position to properly engage the torque wrench.
5. With a continuous motion/force on the tool torque to tighten.
6. Once nut breaks static quickly stop force and read measurement.

7. Follow the torque check pattern provided above and record torque number in the chart.
8. If the lug nuts were not at the correct torque spec then tighten to the specification and perform *How to Determine if Wheel to Rotor Interface Click Noise is Present*.
9. If the clicking noise is still present then perform the wheel to rotor cleaning procedure in bulletin 17–NA-271.
10. If the noise is gone then no repairs need to be performed. The noise was due to the loose lug nuts.
