Service Bulletin

Bulletin No.: 18-NA-049

Subject: Clunk or Growl Noise Coming From Rear of Vehicle and/or Rear End Binding When Turning or Backing Up

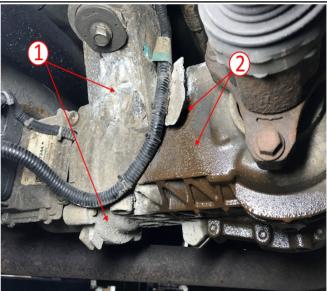
4970620

Involved Region or Country	North America
Additional Options (RPOs)	F46
Condition	Some customers may comment on one or more of the following conditions: Clunk or growling noise from the rear of vehicle Rear differential binding when turning or backing up Some technicians may find a fluid leak coming from the rear differential during inspection.
Cause	This condition may be caused by loss of fluid as a result of corrosion or excessive wear to the Rear Differential housing.

If the clunk or growling noise has been isolated to the rear differential, proceed to inspect the rear differential for signs of corrosion (1), cracking or leaking (2):

- If excessive signs of corrosion have led to cracking and/or leaking from the rear differential, please take pictures of the area of concern, attach to the claim to the report and proceed to the Service Procedure section in this bulletin.
- If no visual defects are found at the rear differential, refer to SI for further diagnostics.

Replace the rear differential carrier assembly. Refer to Differential Carrier Assembly Replacement in SI.
