Service Bulletin

Bulletin No.: 18-NA-052

Subject: Diagnostic Tip for Decreased Air Flow Coming Out from Front Instrument Panel Outer Air Outlet Vents While Driving

Brand:	Model:	Model Year:		VIN:		Engine:	Transmission:
		from	to	from	to		
Cadillac	CT6	2016	2018

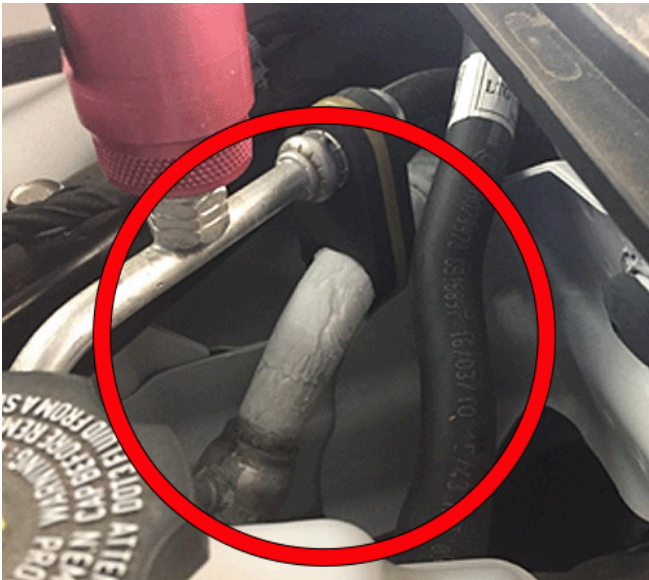
</div> <p>4921770</p> <p>This condition may be due to the seal not sealing the evaporator core completely, allowing air to bypass between the evaporator core and cause a false reading of the evaporator temperature sensor, causing the evaporator core to ice up.</p>
