# Service Bulletin

Bulletin No.: 18-NA-054

**Subject: Momentary Sharp Deceleration During 1-2 Upshift or a Momentary Neutral During 2-4 Upshift, Transmission Stuck in 2nd Gear (fluid below 32°F), Malfunction Indicator Lamp (MIL) Illuminated - DTC P2820 Set During Cold Ambient Temperatures**

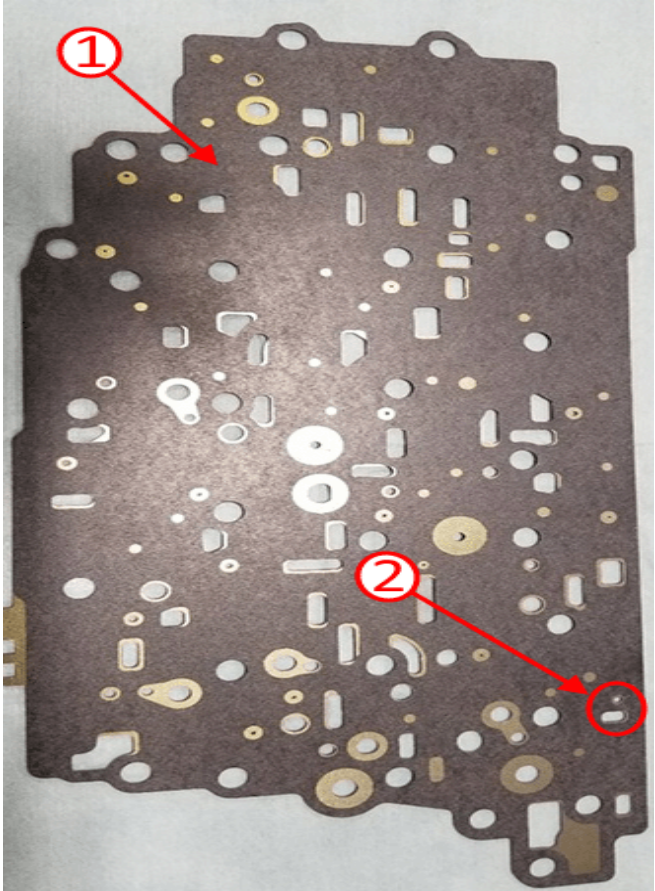
<p style="text-align: right;">4885522</p> <p>This condition may be caused by the spacer plate (1), located between the valve body and the transmission case as an orifice (2), that is undersized.</p> <p>⇒ The consequence is the clutch select moves slowly to release the selectable one way clutch, which causes a momentary transmission tie up during the 1-2 upshift.</p>
<p>Correction</p>	<p>Inspect valve body spacer plate orifice for proper size and replace as necessary following current SI instructions.</p>
