Service Bulletin

PRELIMINARY INFORMATION

Subject: Exhaust Leak or Vibration/Rattle Noise at Approximately 900 RPM, Fuel Smell, White Smoke, Oily Substance on Exhaust Downpipe

Models: 2011-2016 Chevrolet Express 2500/3500/4500
2011-2015 Silverado 2500HD/3500HD
2011-2016 GMC Savana 2500/3500/4500
2011-2015 Sierra 2500HD/3500HD
Equipped with 6.6L Duramax® Diesel Engine (RPOs LML or LGH)

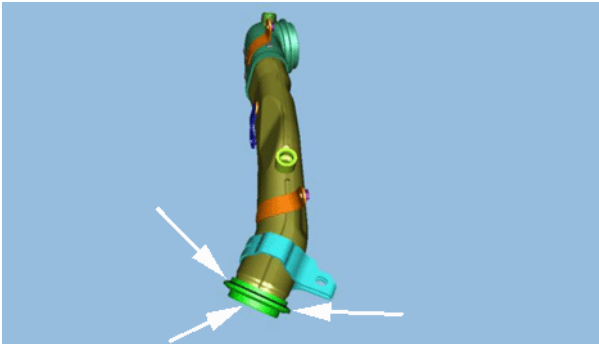
Note: The illustration above is the updated turbocharger exhaust pipe with a pilot flange.

If the above alignment procedure does not correct the condition, the turbocharger exhaust pipe may need to be replaced on trucks built prior to the breakpoints listed below with an updated turbocharger exhaust pipe with a pilot flange. If the turbocharger exhaust pipe has the new flange, you should not need to replace it. Refer to the Turbocharger Exhaust Pipe Replacement procedure in SI.

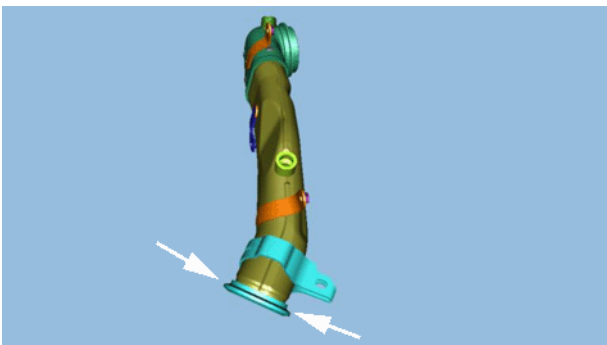
Note: The illustration above is the turbocharger exhaust pipe without a pilot flange.

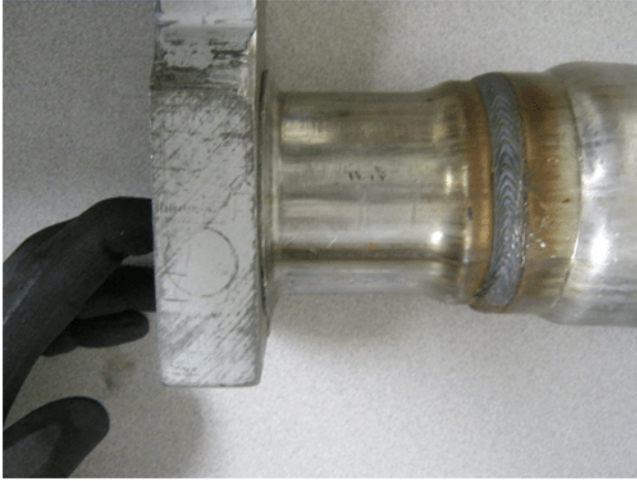
In most cases it will not be necessary to replace the exhaust downpipe/catalytic converter assembly for this condition. However if the mating flange on the exhaust downpipe/catalytic converter assembly is not true, it is possible a leak may occur.

This can be inspected easily by placing a gauge block flush against the flange and inspect for excessive gaps or damage to the flange.

If there are gaps, the converter may need replacing, but the new gasket should compensate for minor surface variation. It is preferred that the alignment process is attempted prior to replacing the converter. There have been very few cases that required the converter to correct this condition.
