Service Bulletin

Subject: Aftermarket Installed Service, Tool or Utility Box Sagging, Mis-aligned, Forward Box Mount Bracket Fractured on Trucks Equipped with Aftermarket Bodies

Models: 2011-2018 Chevrolet Silverado 2500HD-3500HD Series
2011-2018 GMC Sierra 2500HD-3500HD Series
Incomplete Vehicles Equipped with RPO ZW9 Box Delete and Aftermarket Bodies

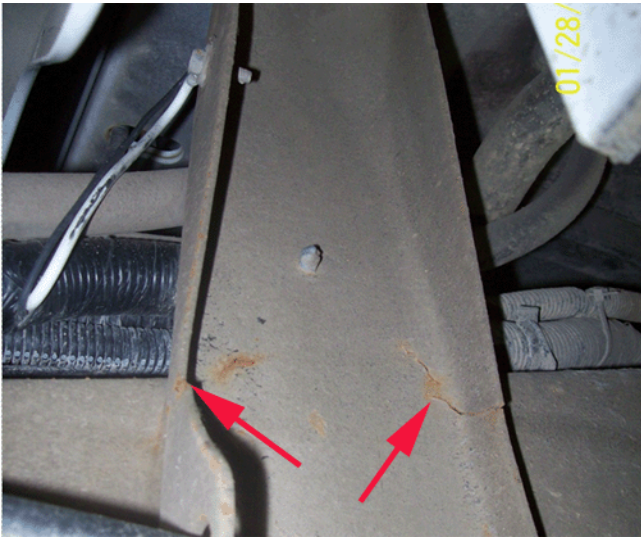
Example of mounting bracket with cracks developing (not all mounting points used).

Some customers may comment that the utility box is sagging, not level or misaligned. Upon inspection, the technician may find cracked or fracture front bed mount bracket(s).

As a result of the installation of the aftermarket box/bed not utilizing all the available attachment points, vehicles may require the installation of replacement brackets to address or assist with customer concerns.

Use the following steps to replace the affected front bed mount brackets.

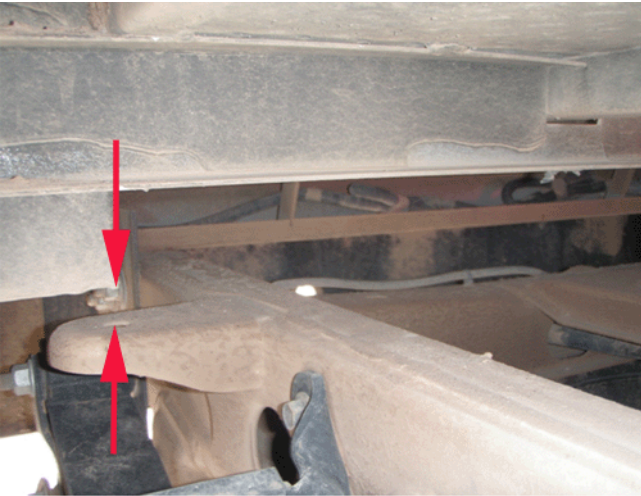
In rare occasions, situations have been identified where the incomplete pickup trucks have had an aftermarket body (typically a service body or util type body) installed. Upon inspection it was noted that the aftermarket bed was not using all the recommended/available mounting points provided Upfitter Integration UI Bulletin # 98 (available at www.gmupfitter.com). Every case identified so far involved an aftermarket body that only used four mounting points; one in each corner, with no additional load bearing points as described in the UI Bulletin.

Example of available body mounting locations not used by the upfitter under the service body.

Important: If the existing body is going to be re-installed after the repair, then the mounting set up of the body that contributed to this condition must be corrected to utilize the attachment scheme outlined in the UI Bulletin prior to performing the re-installation of the body. This repair only replaces same style of bracket, which requires the correct mounting of the aftermarket body. If the body is not mounted properly, the condition may repeat. Refer to GM Upfitter Bulletin #98' for 2011 & beyond 'C/K HD Cab Chassis Mounting Guidelines' and "GM UI Body Builder's Manual Best Practice welding safety & procedures and body mounting information."

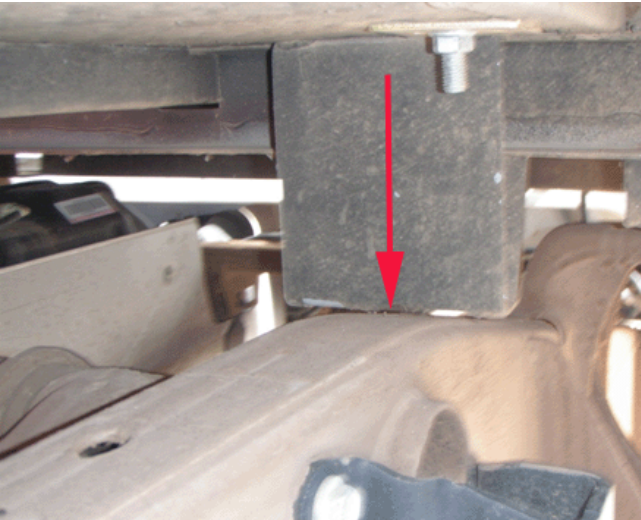
Example of support bracket not carrying any load of the body.
