**Subject:** Engineering Information — Charge Air Cooler Ice Blockage with Malfunction Indicator Lamp Illuminated and DTC P0299 Set After Completing Bulletin 18-NA-020

| Brand: | Model: | Model Year: | | VIN: | | Engine: | Transmission: |
|---|---|---|---|---|---|---|---|
| Chevrolet | Equinox | 2018 | 2018 | | | LTG or LYX | All |
| GMC | Terrain | 2018 | 2018 | | | | |

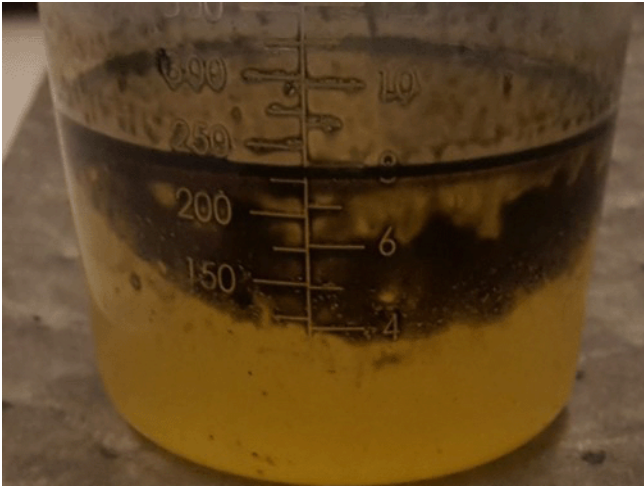
3. Visually inspect the charge air cooler recessed hole in the outlet tank for moisture.

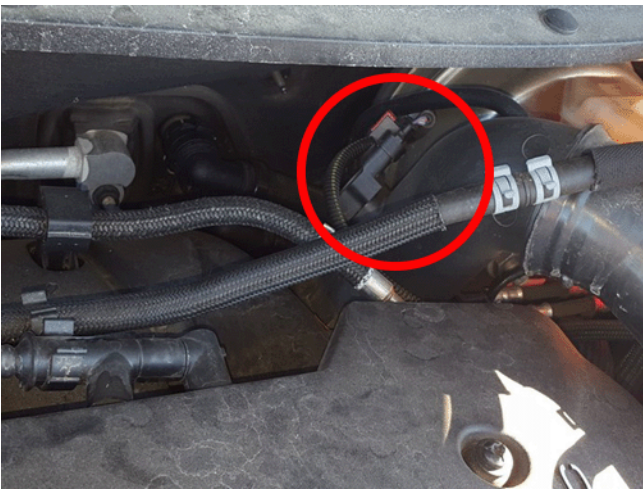
- Photograph any moisture that may be present, then thaw, drain, and measure.
