Service Bulletin

Bulletin No.: 17-NA-019

Subject: Apple Carplay Will Not Launch After 1124 Key Cycles, Clock Resets to 12, Blank Screen, Poor Sound Quality during Bluetooth Calls, XM Audio Loss

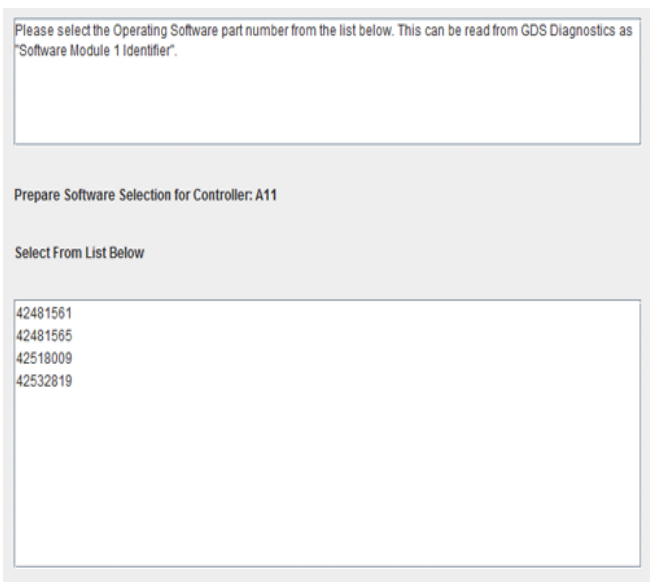
4742958

Important: If the “Software Module 1 Identifier” is requested at the start of A11 Radio - Programming as shown in the example below, DO NOT pick a random number from the list or the wrong SPS programming files will be installed. If this is displayed, pick the “Selected” part number you noted earlier. If you did not note the “Selected” part number as outlined above, you can still obtain it by closing TIS2web and noting the 8-digit “Software Module 1 Identifier” using the following GDS2 path: *Module Diagnosis>>Radio>>Identification Information>>Software Module 1 Identifier*. Once this number is noted, close GDS2 and return to A11 Radio – Programming in TIS2web.
