Service Bulletin

Bulletin No.: 17-NA-103

Subject: Airbag Indicator Illuminated - DTCs B0012, B0013 Set

Brand:	Model:	Model Year:		VIN:		Engine:	Transmission:
		from	to	from	to		
Buick	LaCrosse	2016	2017	SOP	Oct., 2017		
Chevrolet	Malibu				Nov., 2017

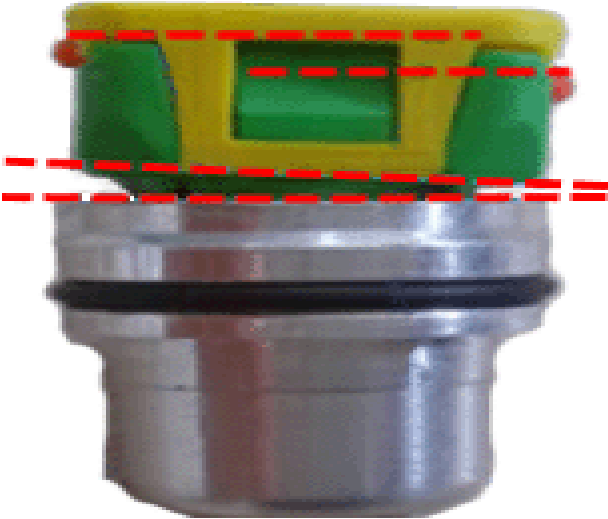
</div> <p style="text-align: right; font-size: small;">4967085</p> <p>This condition may be caused by the steering wheel airbag electrical connector loose or not being fully seated.</p>
Correction	<p>Important: Do Not replace the steering wheel airbag for this concern. If you encounter a vehicle with either DTC set, inspection of the driver's side steering wheel airbag electrical connectors must be performed using the Service Procedure below.</p>

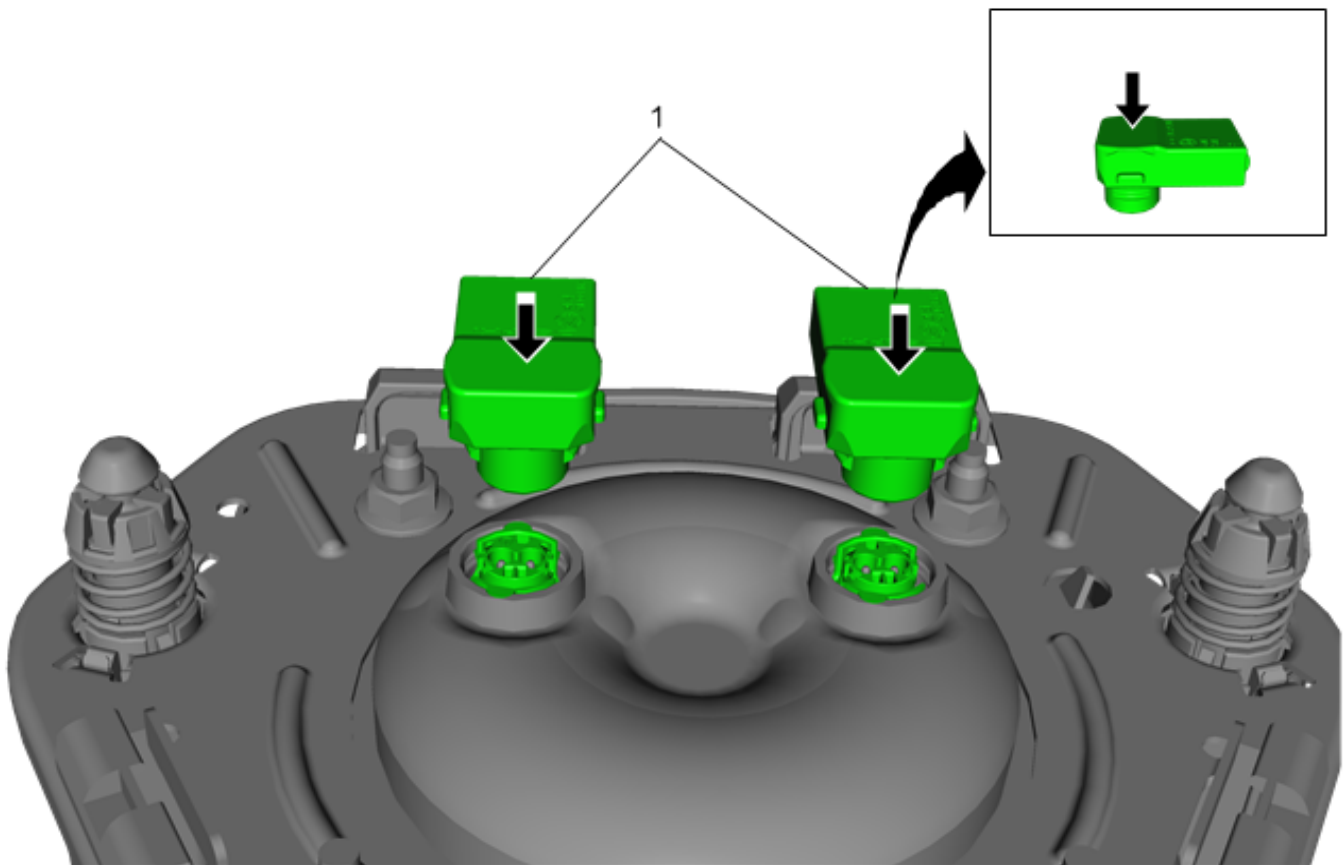
4971166

2. Inspect the airbag electrical connectors and Connector Position Assurance (CPA) for proper installation:

- If the airbag electrical connector (1) is not fully seated, disconnect then reconnect the electrical connectors into the squib assembly until a clear “click” can be heard.
 - If the airbag electrical connector is fully seated, follow the diagnostics for the DTCs set in SI.
3. Install the steering wheel airbag.

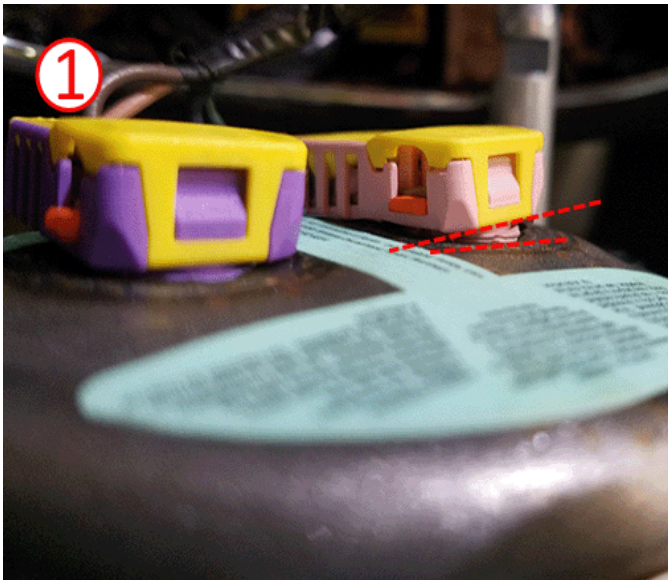
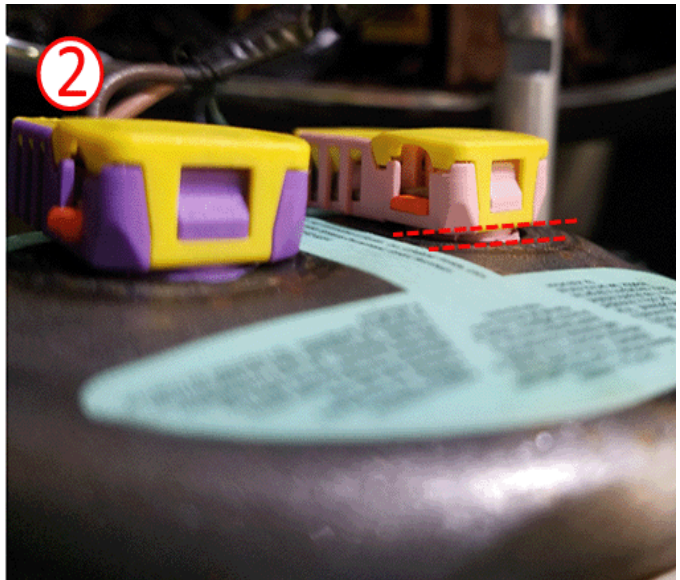
4967796

In the example above, it was found that the connector was not locked in completely (1), causing the wiring to move or lose connection while vehicle was moving. The push/push test (NOT A “push/pull”) was performed on the connector ensuring proper connection with a noticeable difference in how the connector was seated into the airbag (2).
