Service Bulletin

Bulletin No.: 17-NA-110

Subject: Low Coolant in Surge Tank and/or Intermittent Low Coolant Message Displayed

Brand:	Model:	Model Year:		VIN:		Engine:	Transmission:
		from	to	from	to		
Chevrolet	Silverado	2017	2018			L5P	All
GMC	Sierra	2017	2018			L5P	All

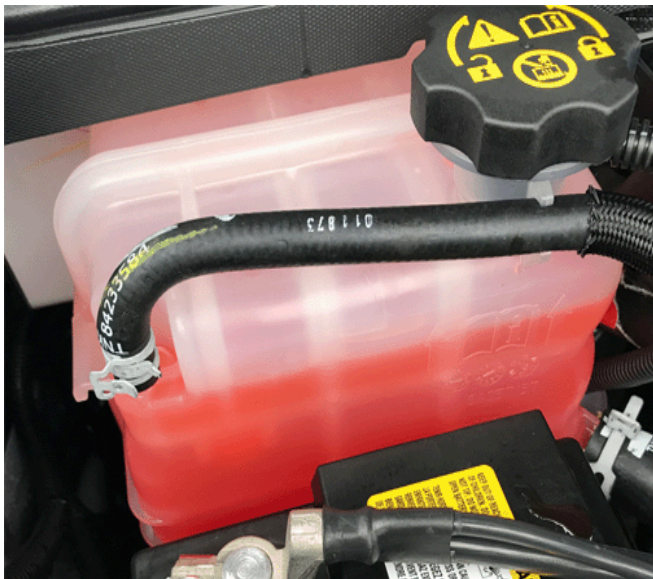
4958429

Involved Region or Country	North America, Israel
Additional Options (RPOs)	Equipped with Diesel Engine (RPO L5P)
Condition	Some customers may comment on the coolant surge tank appears low and/or a low coolant message displayed intermittently.
Cause	This may be due to the fill process at the plant cannot purge all of the air from the cooling system and surge tank. After the engine has been thermally cycled, air rises causing the coolant to become lower than initially viewed.
Correction	Add 1 quart (0.946 L) of coolant to the upper chamber of the surge tank in order to bring the level up to the bottom of the fill neck.

Improperly Filled System

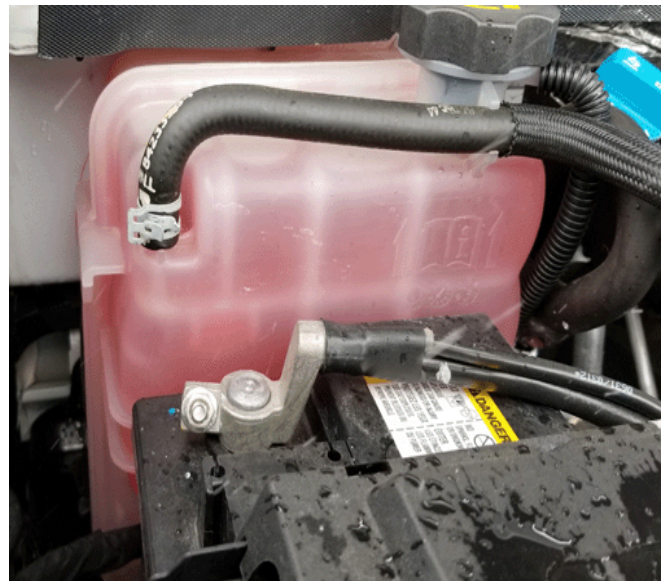
4958431

Properly Filled System
