Service Bulletin

Bulletin No.: 17-NA-181

Subject: Reduced Throttle, Engine Stalling, No Crank/Start, ABS Light On, Malfunction Indicator Lamp (MIL) Illuminated - DTCs P0106, P0107, P0122, P018C, P0222, P0532, P0561, P0562, P057C, P057E, P0641, P0651, P0697, P06A3, P06D2, P103B, P1682, P16A7 and/or P2128 Set

| Brand: | Model: | Model Year: | | VIN: | | Engine: | Transmission: |
|---|---|---|---|---|---|---|---|
| Chevrolet | Malibu (VIN Z) | 2016 | 2016 | | | 1.5L (LFV) | |

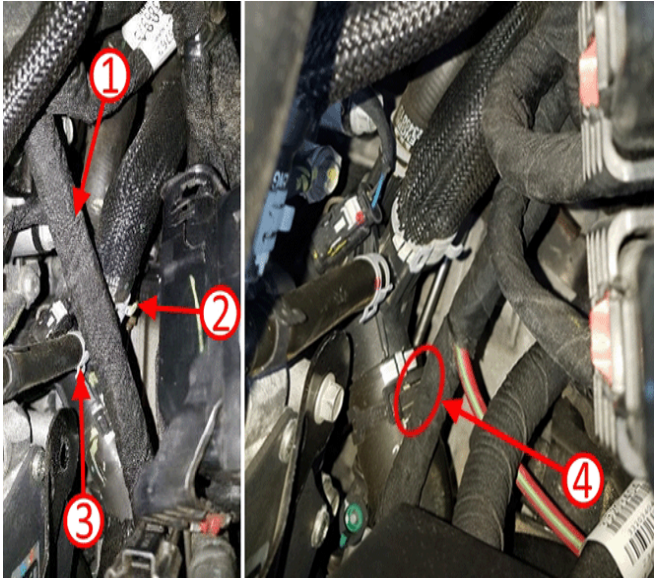
| Cause | <p>4810882</p> <p>Note: This is a multi-wire bundled harness and, depending on which wire is damaged, can set a variety of DTCs.</p> <p>This condition may be caused by the engine harness (1) chaffing between the ECM and rear of engine at one or more of the following locations:</p> <ul style="list-style-type: none"> • Heater inlet hose clamp (2) • Engine coolant air bleed hose clamp (3) • Upper radiator inlet coolant hose clamp (4) |

| Correction | If any of the above conditions have been validated, inspection of the engine wiring harness must be done and repositioning of the coolant hose clamp. |

1. Inspect the engine wiring harness for contact at the upper coolant hose clamp.
 - If the wiring harness shows no signs of damage, refer to SI for further diagnostics.
 - If the wiring harness shows signs of chaffing, proceed with procedure.
2. Repair the wiring harness. Refer to *Wire to Wire Repair* in SI.
3. Wrap the engine wiring harness with Polyester Electrical/Anti-Abrasive Tape (PET) or equivalent anti-abrasion tape.
4. Reposition the coolant hose clamps so that it cannot contact the engine harness.
