Service Bulletin

Bulletin No.: 17-NA-215

Subject: Red LED, No WiFi Operation, and/or Limited OnStar® Module Functionality After OnStar Module Replacement for Another Condition

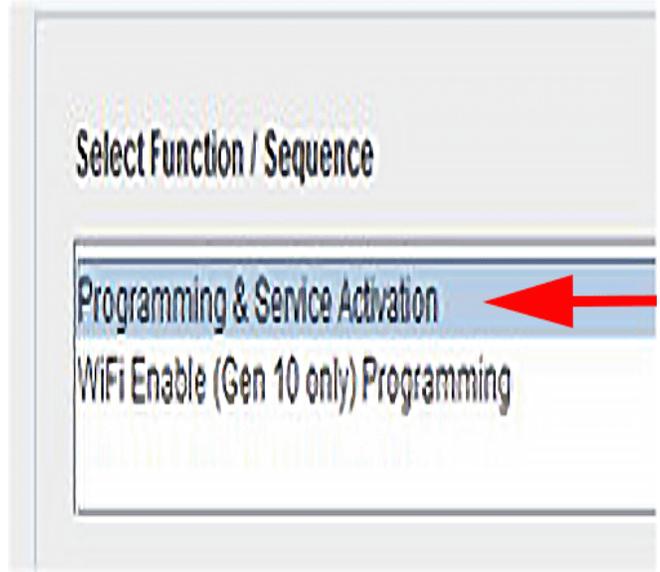
4829365

1. All replacement OnStar® modules require TIS2web programming – refer to every step of the “Communication Interface Module Programming and Setup” procedure in SI (*or equivalent) for details.

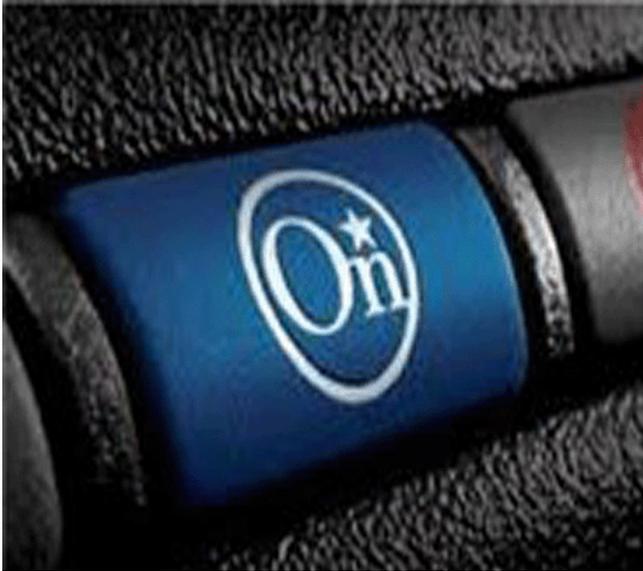
4829369

5. Do not select the “OnStar WiFi Enable (Gen 10 only) Programming” procedure until immediately after the TIS2web “Programming and Service Activation” procedure has been completed (RPO VV4 only).
