Service Bulletin

File in Section: 08 - Body and Accessories Bulletin No.: 09-08-64-014C Date: March. 2018

- Subject: Information on Side Window Glass Not Clearing Molding When Indexing Down During Door Opening
- Models: 2010-2018 Chevrolet Camaro
- Attention: This Bulletin also applies to any of the above models that may be Export from North America vehicles.

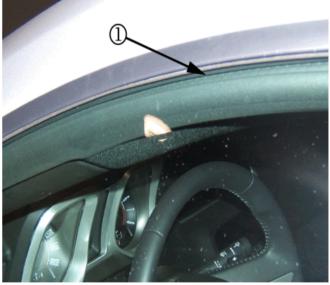
2261663

Door in "Closed" Position (1)

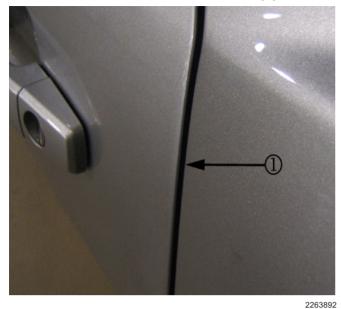
Window in "Indexed" Position (1) (When Door Latch is Opened)

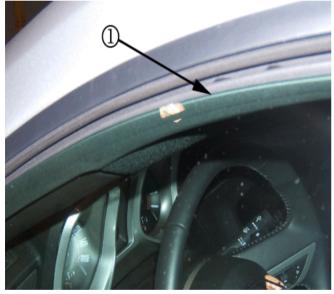
2261664

Door in "Open" Position From 1 mm (0.039 in) to 7.5 mm (0.295 in) (1)
