Subject: Engineering Information — Malfunction Indicator Lamp Illuminated with DTCs P2101 Throttle Actuator Position Performance and/or P2119 Throttle Closed Position Performance

Brand:	Model:	Model Year:		VIN:		Engine:	Transmission:
		from	to	from	to		
Chevrolet	Colorado	2017	2018			LGZ	All
GMC	Canyon	2017	2018

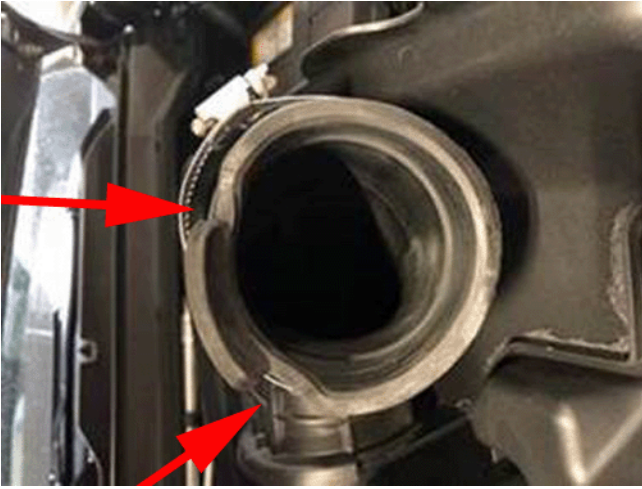
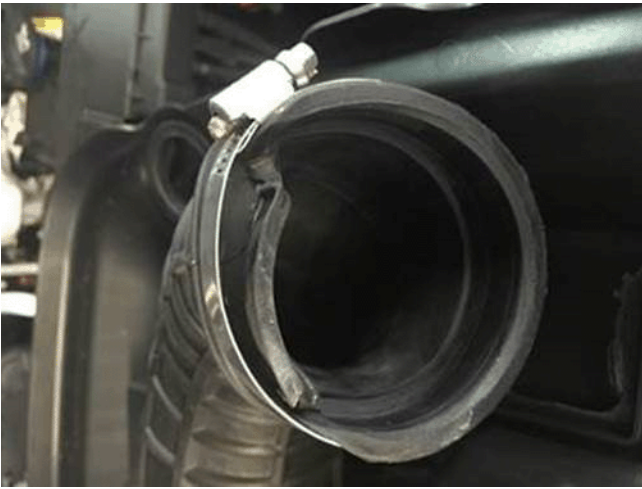
2. Inspect for any deformation of the air inlet as shown above. If air inlet is deformed or damaged in anyway way it will be necessary to replac and retest. Take care when installing new air inlet to not damage the sealing surface
3. Prior to disconnecting throttle body connector ensure that it was properly seated. It will also be necessary to then Inspect the throttle body connector to ensure that there are no terminal issues and the connector is free from any contamination.
4. Using your hand, ensure that the throttle body blade is moving freely.
5. Contact the engineer listed below with findings.

1. Ensure that the inlet air duct to throttle body is not out of place and installed correctly.
