# Service Bulletin

Bulletin No.: 16-NA-016

**Subject: Rear 60% Seatback Locked in Down Position When Folded, Will Not Return to Upright Position**

Brand:	Model:	Model Year:		VIN:		Engine:	Transmission:
		from	to	from	to		
Buick	Encore	2013	2016			All	All
Chevrolet	Trax	2013	2016

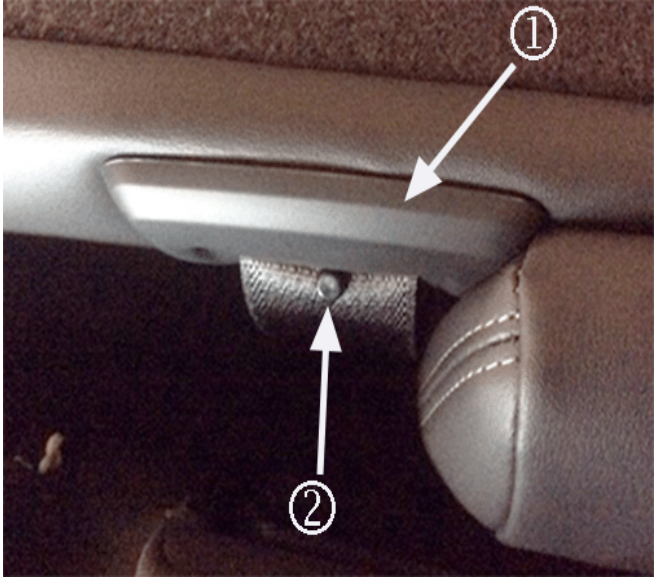
<b>Involved Region or Country</b>	North America, South America
<b>Condition</b>	  <p style="text-align: right; font-size: small;">4363659</p> <p>Some customers may comment that after folding the 60% seatback, it is locked in the down position and will not return to upright.</p>

<p style="text-align: right;">4363662</p> <p>The cause of the locked condition may be either of the following:</p> <ul style="list-style-type: none"> <li>• When the front seat is all the way back and the rear 60% seatback is lowered, the added weight of the front occupant puts extra pressure on the seat belt bezel (1) and button/stop (2). This may allow the seat belt to fully retract <b>past the stop</b>, and the retractor may lock because there is not enough seat belt slack to unlock the retractor.</li> <li>• A broken or missing seat belt button/stop on the rear center seat shoulder belt.</li> </ul>
--------------	--

**DO NOT** replace the shoulder belt assembly for this condition until first attempting to disengage the locking mechanism by following the Recommendation listed below.

Pull hard on the locked webbing and then release. The hard pull extracts a small amount of webbing from the retractor which, in turn, permits a small amount of retraction to occur when released. This is all that is needed to disengage the locking mechanism. The safety belt will now function properly.

In cases where the locking mechanism will not disengage, cut the shoulder belt and replace the shoulder belt assembly as directed in the Service Procedure below.

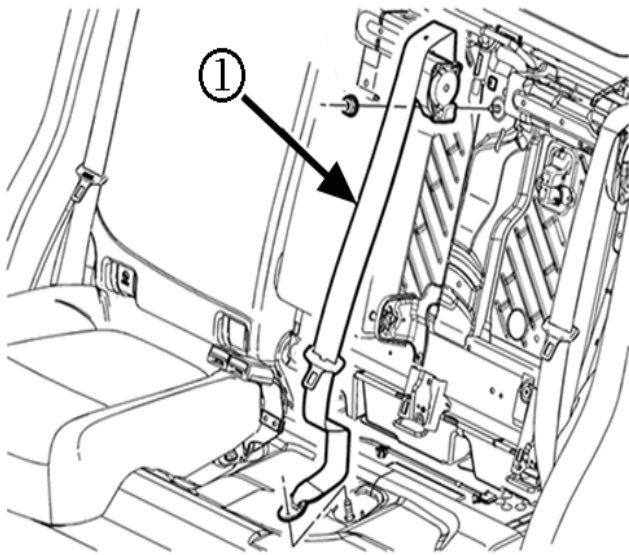
4363667

**Note:** The shoulder belt assembly service part may be one of 2 different designs. The service part you receive **may, or may not**, contain the mini button/stop (1) shown in the graphic above, and either design is OK to use.
