Service Bulletin

Bulletin No.: 16-NA-060

Subject: Difficulty Shifting Out of Park or into Park

Brand:	Model:	Model Year:		VIN:		Engine:	Transmission:
		from	to	from	to		
Chevrolet	Malibu (VIN Z)	2016	2016				MKE, MNH, MNM, MRC
	Volt	2016	2017				MKV

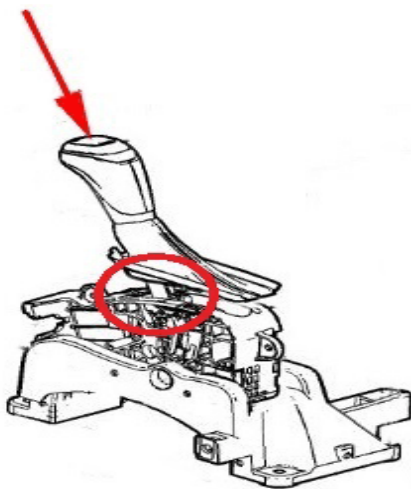
4421604

While pressing downwards on the knob firmly with both hands, validate any movement felt and the bottoming out of the knob to shifter.

Do not immediately replace any parts until the transmission control lever knob assembly has been validated to be fully installed onto the shifter and operating correctly.

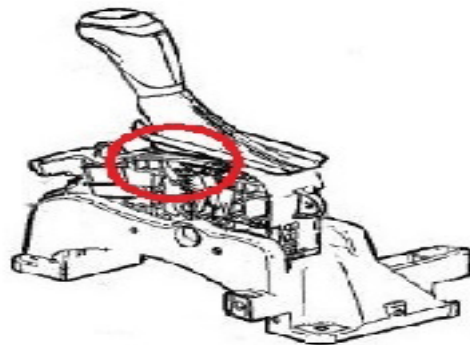
4421606

- If movement was confirmed and the knob is fully seated onto the shifter, verify the shifter assembly moves freely.
- If this does not correct the concern, proceed to the following Second Check for further diagnostics.
