Service Bulletin

Bulletin No.: 16-NA-079

Subject: Audio System Speaker Rattle, Buzz Noise, Poor Sound When Playing Radio or Other Music Source

Brand:	Model:	Model Year:		VIN:		Engine:	Transmission:
		from	to	from	to		
Chevrolet	Colorado	2015	2018			All	All
GMC	Canyon	2015	2018			All	All

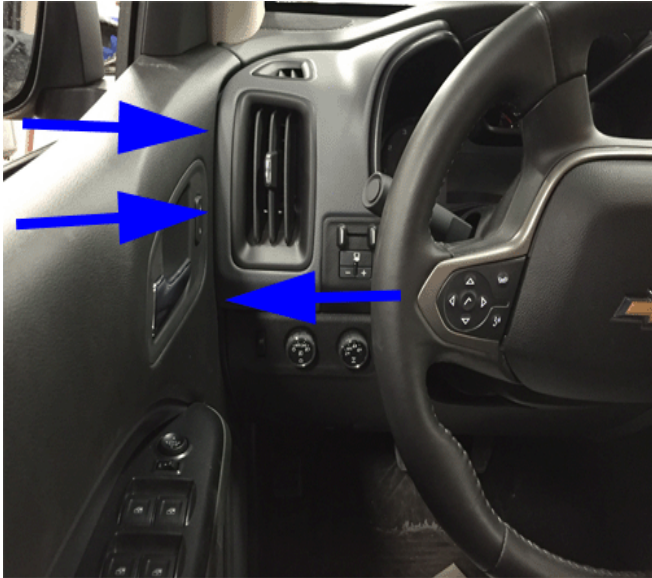
4426926

Loose Trim, Panel to Panel Contact

An interface may cause a rattle or buzz (for example, between a door and instrument panel).

- If the rattle or buzz is determined to be coming from the instrument panel, inspect for loose panels, screw covers or contact between trim panels such as an A pillar to instrument panel interference.

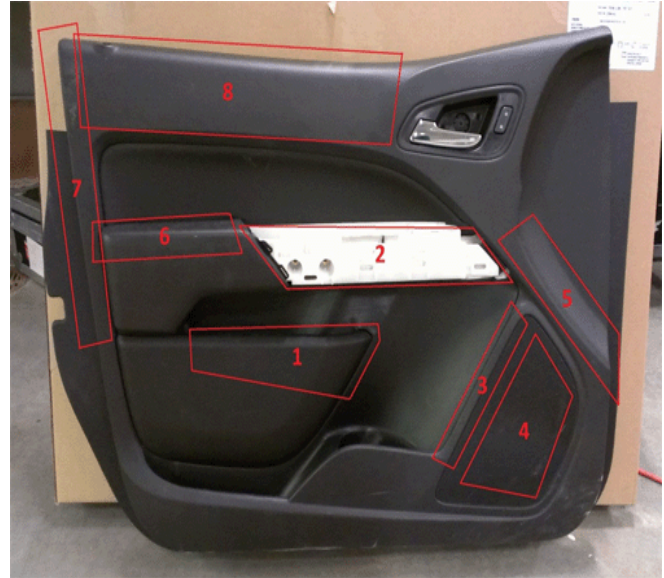
4426929

Door Trim/Water Deflector/Harness Rattle

If the rattle is heard within the door trim, check the locations shown above by depressing the trim with your hand. If the sound changes or the rattle/buzz decreases when pressure is applied, follow the steps below.
