Service Bulletin

File in Section: -
 Bulletin No.: 17-NA-238
 Date: March, 2018

Subject: Wi-Fi Hotspot and/or Data Sharing Feature Not Working Once it is Turned On

Brand:	Model:	Model Year:		VIN:		Engine:	Transmission:
		from	to	from	to		
Chevrolet	Sonic, Trax	2018	2018				
GMC	Terrain

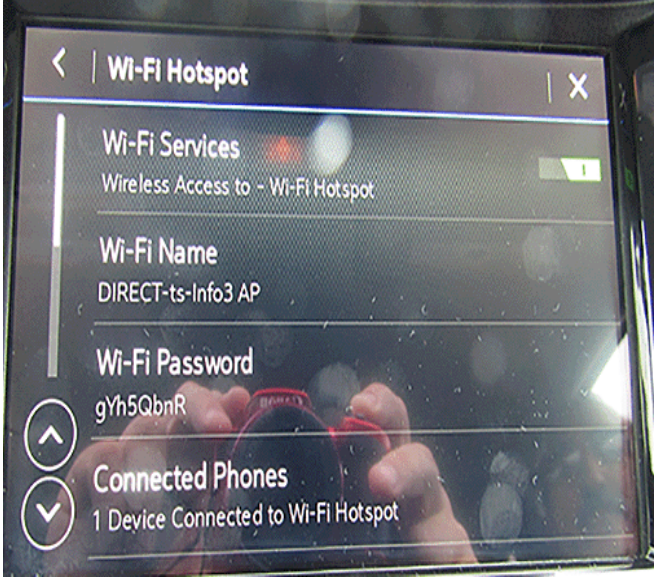
4846535

Involved Region or Country	North America and N.A. Export Regions
Additional Options (RPOs)	Equipped with RADIO-INFOTAINMENT SYSTEM - 3.X LOW HMI, MIDLEVEL CONNECTIVITY 3.X (RPO IOR)
Condition	<p>Some customers may comment that the Wi-Fi hotspot is turned on but the connected device(s) does not work.</p>

<p style="text-align: right;">4846537</p> <p>There are two settings icons that have to be toggled (switched) “on” to “green” to enable Wi-Fi: hotspot and share hotspot data. Note: The Hot Spot feature in the vehicle comes in the off state from the factory.</p>
Cause	This is design intent for Radios with software level prior to 131.155.
Correction	<p>Note: Radios built with software level 131.155 or higher have both switches on by default.</p> <p>Radios with software level prior to 131.155 will need to toggle BOTH switches on, the Wi-Fi hotspot and hotspot data on the display.</p>
