# Service Bulletin

Bulletin No.: 17-NA-240

**Subject:** Front Bumper Fascia Out of Alignment

Brand:	Model:	Model Year:		VIN:		Engine:	Transmission:
		from	to	from	to		
Buick	Encore	2017	2017	SOP	September 1, 2017	All	All

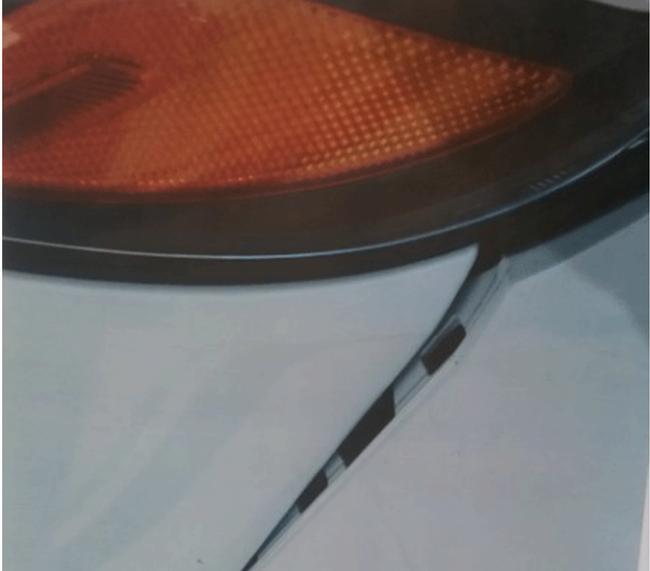
<p style="text-align: right; font-size: small;">4840393</p>
<b>Cause</b>	Some customers may comment that the front fascia is loose or out of alignment. This may be due to the body mounting surface being out of specification.
<b>Correction</b>	Repair the front bumper by following the Service Procedure listed below.
