# Service Bulletin

**Subject:** Radio Resets, Navigation Inoperative, Map Not Displayed, DVD Will Not Play or Resume, Bluetooth® Inoperable, Radio Lockup, Voice Recognition Cuts Off, USB Source not Returning to Last Song, OnStar® Default Volume Low

**Models:** 2013-2014 Buick Enclave  
2013-2014 Chevrolet Traverse  
2014 Chevrolet Captiva  
2013-2014 GMC Acadia  
Equipped with Radio RPO UHU, UG4, UGU, UGY, UGX, UHW or UHV

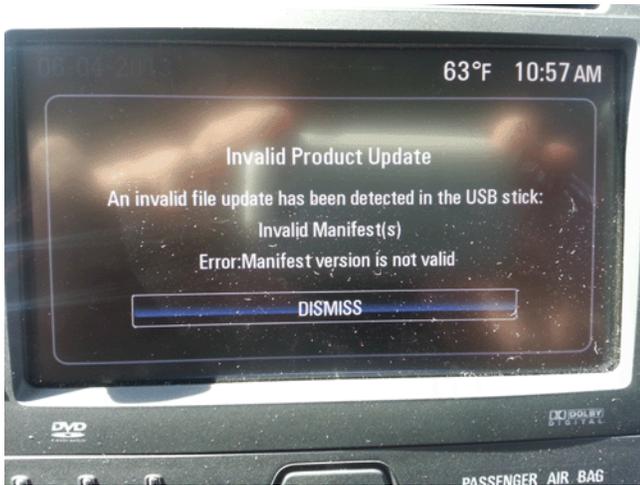
**Note:** If the following screen above is shown on the screen, the radio already has the latest calibration installed and no further action is required.
