Service Bulletin

PRELIMINARY INFORMATION

Subject: Warm Air Exhausting from Driver and/or Passenger Front Seat Back into 2nd Row Seating Area Causing Occupant Discomfort

Models: 2015-2019 Cadillac Escalade Models
2014 Chevrolet Silverado 1500
2015-2016 Chevrolet Silverado, Suburban, Tahoe
2014 GMC Sierra 1500
2015-2016 GMC Sierra, Yukon Models
Equipped with Heated and Cooled Seats - Driver and Passenger Front (RPO KB6)

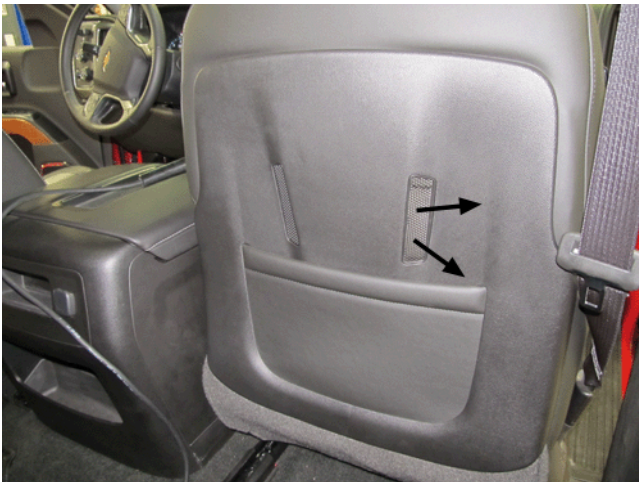
Some customers may comment on warm air exhausting from the driver/passenger front seat back into the 2nd row seating area, causing occupant discomfort.

The cause of this condition may be that during cooled seat operation, a direct flow of warm air exhausts from the upper seat back ventilation heating/cooling blower thermal exchange blower unit.
