Service Bulletin

PRELIMINARY INFORMATION

Subject: Intermittent Home Screen Icon/Navigation Overlay, Intermittent RVC Black Screen with Guidelines, Phone Pairing Not Included on the Phone Page, Routing Issues on Toll Roads in Mexico

Models: 2015 Buick Enclave
2015 Chevrolet Traverse
2015 Chevrolet Captiva
2015 GMC Acadia
Equipped with Radio RPO UI2, UI4, UI5, UI6, UI7 or UI8

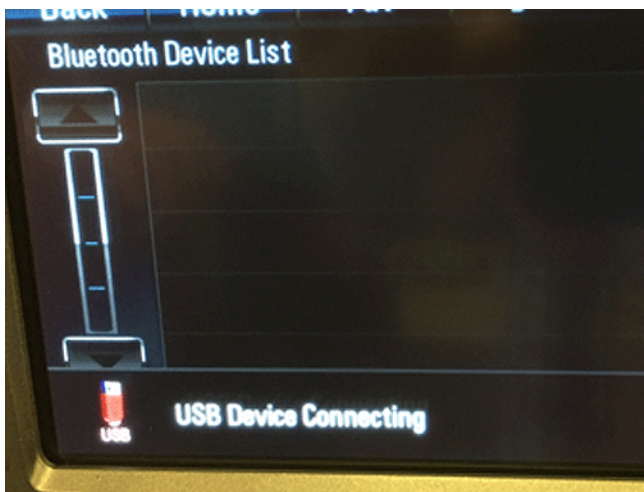
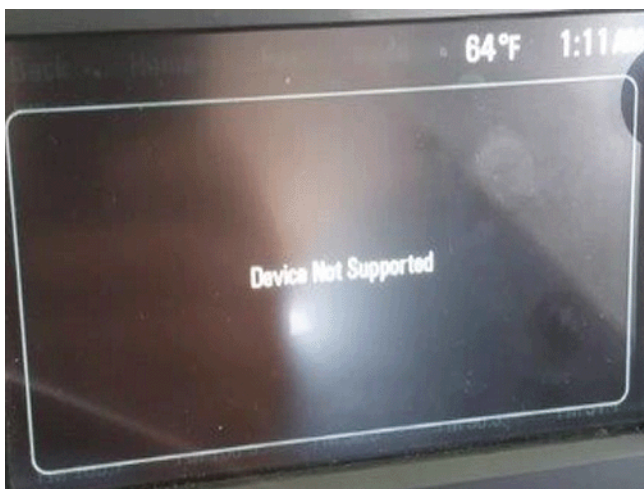
- 2.1. If the “USB Device Connecting” message below is immediately displayed at the bottom of the screen when the USB is inserted, last for about 1 minute, and then the “Device Not Supported” message below is displayed for a few seconds before ultimately aborting a displaying the previous screen again, the USB drive may contain corrupt files. If this is experienced, order a replacement USB by following the instructions at the bottom of this PI.

If the complimentary USB stick has been lost, damaged, or is suspected of causing the "Device Not Supported" message described above in step 2a, you can make a replacement USB stick by following these instructions:

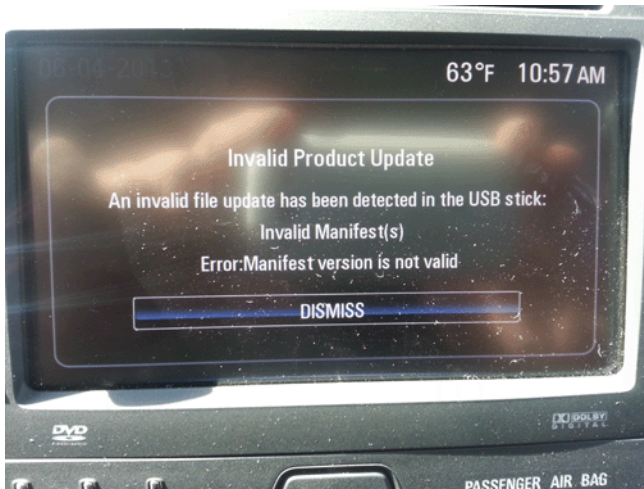
- 2.2. If the following “Invalid Product Update” and “Invalid Manifest(s)” error message is displayed, the radio already has improved calibrations and no further action is required. A DTC B124F may set as a result of this as well.
