# Service Bulletin

Bulletin No.: 18-NA-092

**Subject: Radio Audio Randomly Cuts Out DTC U18B4 - Lost Communication with Radio on Ethernet Bus**

Brand:	Model:	Model Year:		VIN:		Engine:	Transmission:
		from	to	from	to		
GMC	Terrain	2018	2018	SOP	February 1, 2018	All	All

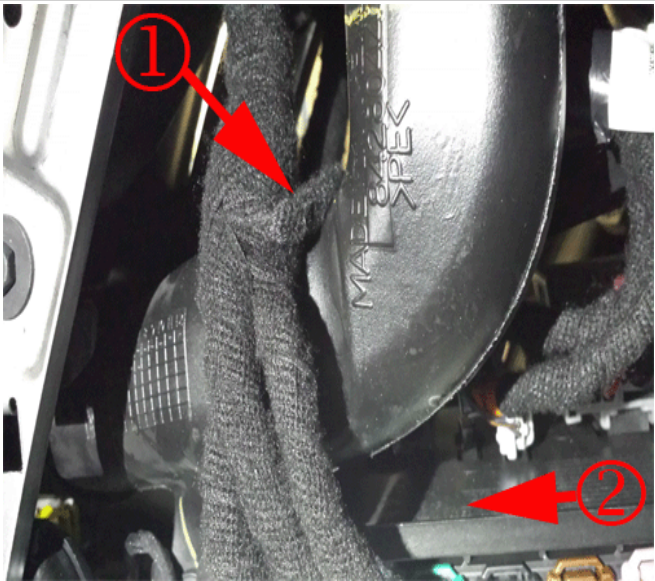
<b>Involved Region or Country</b>	North America and NA Export vehicles
<b>Additional Options (RPOs)</b>	Equipped with Bose Sound System (RPO UQA) and Audio System (RPO IOS, IOT, or IOU)
<b>Condition</b>	Some customers may comment on the radio audio from AM/FM/XM/USB intermittently cutting out or muting. The radio display and audible warnings (chime) will still function properly. Intermittent loss of Radio communication may be noticed and the Amplifier will store diagnostic trouble code (DTC) U18B4 - Lost Communication with Radio on Ethernet Bus.
<b>Cause</b>

<p style="text-align: right;">5026300</p> <p>The IP wiring harness (1) on the right side of the center console near the BCM (2) may have been routed incorrectly. An incorrectly routed harness could cause the terminal(s) to be pulled out of Connector X207 causing an intermittent connection in the ethernet bus.</p>
<b>Correction</b>	Repair damaged terminals and re-route harness by following the procedure below.
