Service Bulletin

Bulletin No.: 18-NA-093

Subject: Low Oil Level Indicator Illuminated

Brand:	Model:	Model Year:		VIN:		Engine:	Transmission:
		from	to	from	to		
Chevrolet Holden	Equinox	2018	2018			LTG	All

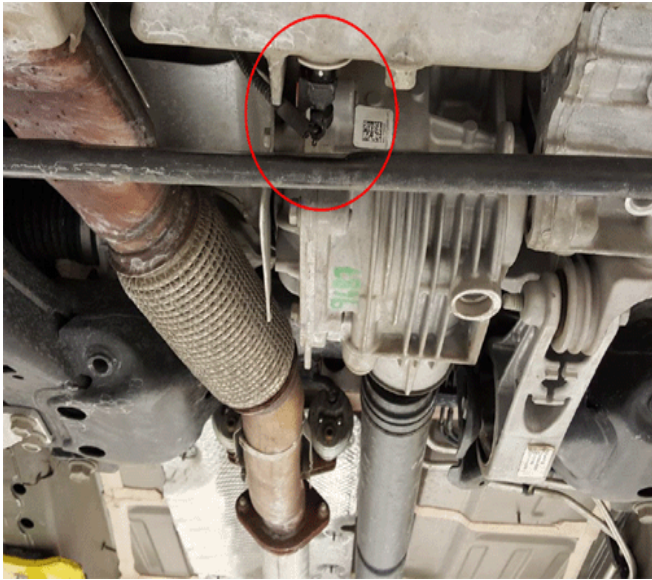
5026306

Note: Correct orientation when viewed from front of vehicle. Note position of relief channel that provides proper clearance between brace and sensor.

4. Torque the new bolts for the brace to 58 Y + 30°-45° (43 lb ft).
