Service Bulletin

Bulletin No.: 17-NA-330

Subject: Normal Characteristic – Push to Talk Button on Steering Wheel Control is Inoperative and/or Cannot Delete USB Names from Radio Display

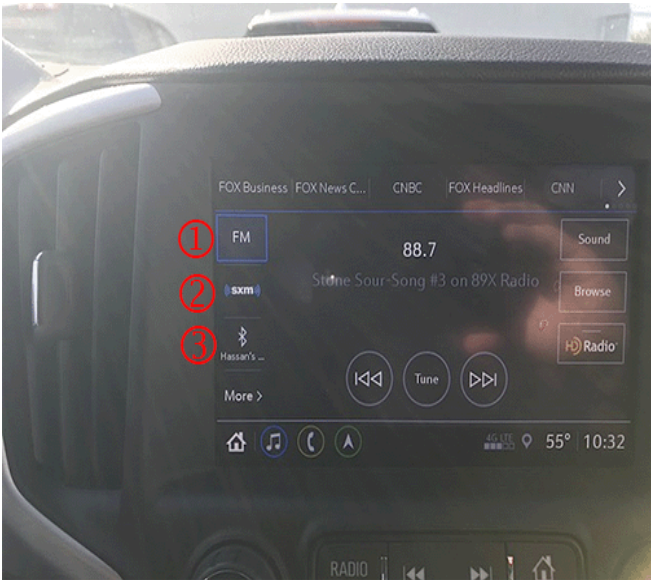
4875408

| Cause | <p>This condition may be due to one of the following:</p> <p>Condition 1, no action is required. It is normal operation if you do not have a phone device paired with the vehicle via Bluetooth.</p> <p>Condition 2, the radio displays the last 3 sources used for the radio like AM, FM, XM, Bluetooth device streaming music or USB drive. The sources are highlighted/actively listed even after the source is removed from the system.</p> <p>To delete the name of the USB from the radio display, push the more button on the display and select another radio sources like AM, FM or XM.</p> |

| | Note: The radio will show the last 3 audio sources after removed, as shown in the illustration above. |

| Correction | DO NOT replace the radio assembly as this is a normal design characteristic for the infotainment system. |
