Service Bulletin

Bulletin No.: 17-NA-347

Subject: Diagnostic Tip for Right and/or Left Rear Tail Lamp Inoperative and/or Turn Signals Flashes to Fast

Brand:	Model:	Model Year:		VIN:		Engine:	Transmission:
		from	to	from	to		
Buick	Enclave	2018	2018				
Chevrolet	Traverse

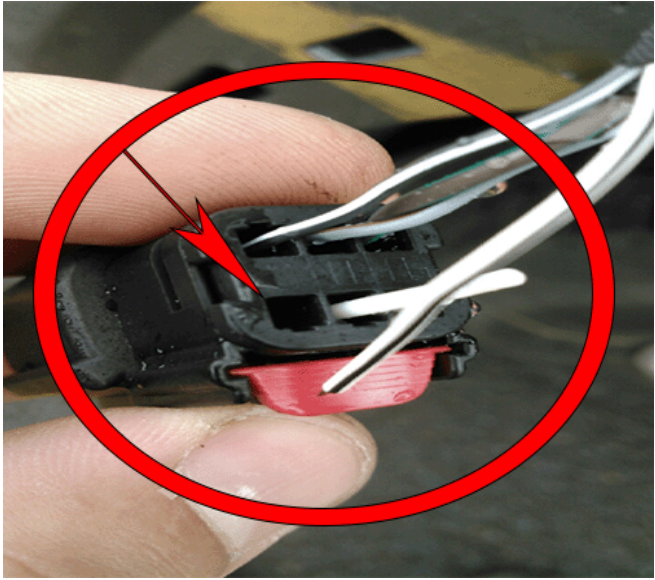
Involved Region or Country	North America and NA Export vehicles
Condition	Some customers may comment on the right and/or left rear tail lamp inoperative and/or turn signal flashes to fast.
Cause	  <p>4890855</p>

<p>4890864</p> <p>This condition may be caused when one of the terminals in the tail lamp connector being pulled out of the connector, or the wire being broken at the crimp. Note: In some cases the wire is broken internal to the insulation.</p>
Correction	Replace the tail lamp harness.

Refer to Tail Lamp Wiring Harness Replacement or Wire to Wire Repair in SI.
