# Service Bulletin

Bulletin No.: 17-NA-152

Date: April, 2018

**Subject: Front Power Seat Slight Rocking Movement While Shifting Weight from Seat, During Hard Stops, and/or When Driving Over Rough Road Surface**

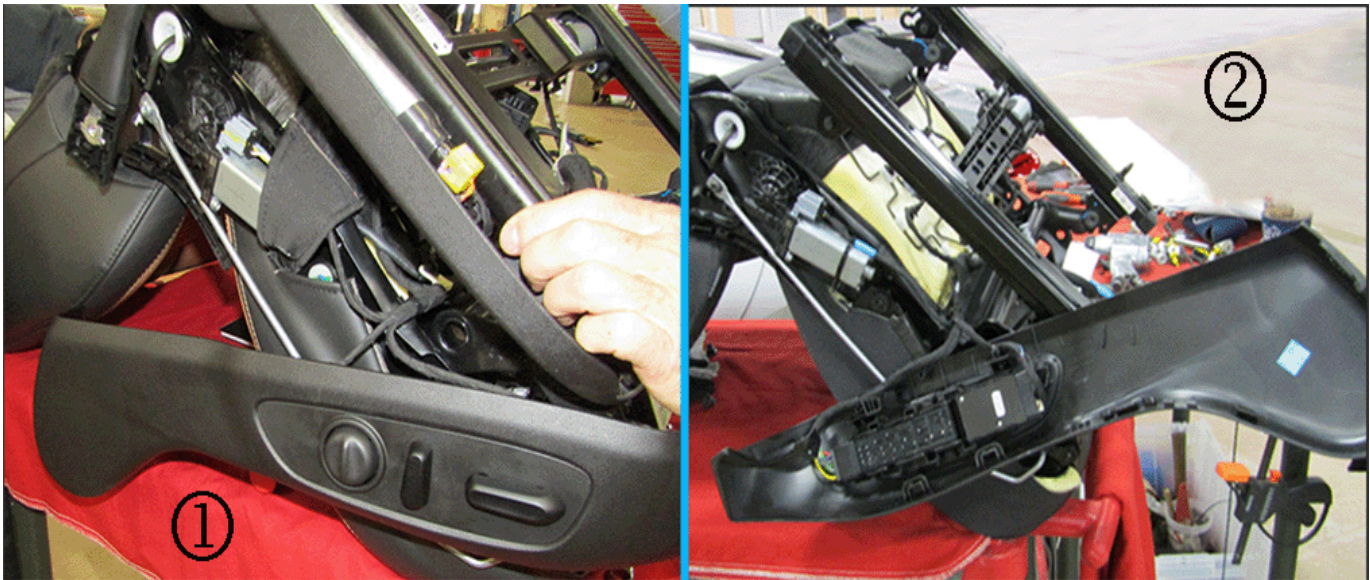
4975754

**Note:** Removal of the seat cushion outer finish cover is necessary to access the seat motor and also achieve torque wrench access to all three fastener positions. Examples of an Equinox seat (1) and a Malibu seat (2) are shown in the graphic above.

4. Remove the seat cushion outer finish cover. Refer to *Front Seat Cushion Outer Finish Cover Replacement* in SI.

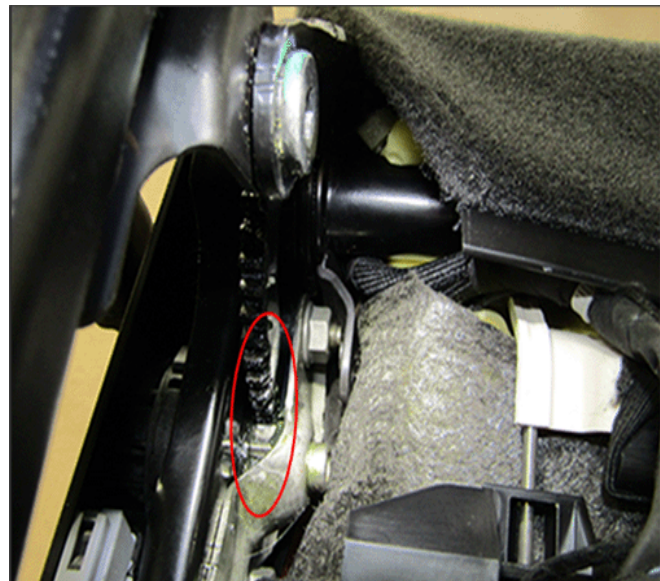
4975757

**Note:** The intent on applying a load to the height adjuster motor is to force full gear mesh, and lessen any teeth clearance between the gear on the actuator and the sprocket on the seat track, reducing seat movement.
