## PIT5572A Service Adaptive Cruise With DTC C018C SYM3A After Replacing K14 Distance Sensing Cruise Control Module

Brand:	Model:	Model Years:	VIN:		Engine:	Transmissions:
			from	to		
Chevrolet	Suburban	2015 - 2018	All*	All	All	All
Chevrolet	Tahoe	2015 - 2018	All*	All	All	All
GMC	Yukon	2015 - 2018	All*	All	All	All

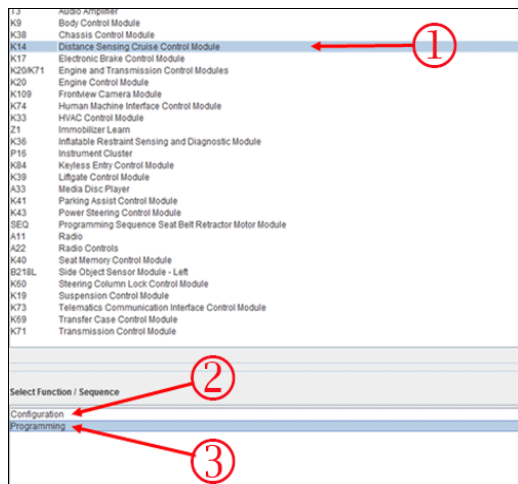
1. Make sure, at the SPS Supported Controller screen, the correct module is being selected. This should be the K14 Distance Sensing Cruise Control Module (1).

2. Make sure, at the SPS Vehicle Options screen, the correct RPO's are selected. These should be "Automatic Cruise Control w/Stop/Go (RPO KSG/K59)" (4).

3. While on the SPS Supported Control screen, the first function performed should be the "Programming" (3) event and then the "Configuration" function should be performed after that (2). At the end of each of these SPS functions, all controller specific instructions MUST be followed. See item #4 below for more details.

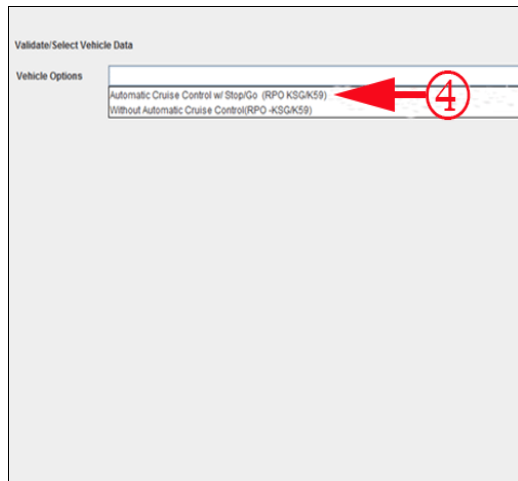
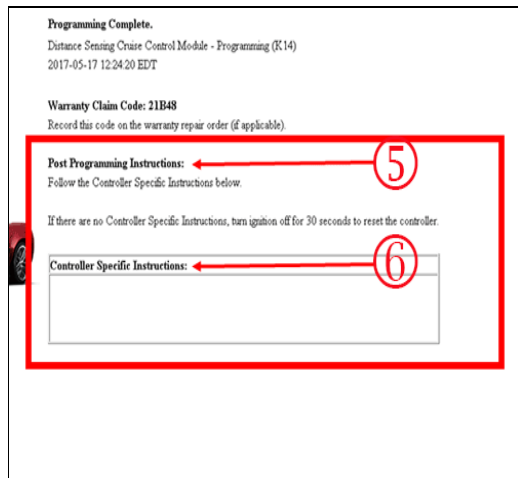
4. THIS IS THE MOST COMMONLY MISSED ITEM - The last screen of the SPS "Programming" and SPS "Configuration" functions list the "Post Programming Instructions" (5). These "Post Programming Instructions" MUST be followed before turning the ignition off. In most cases, the only "Controller Specific Instruction" (6) is to "Clear DTCs", which must be followed before turning the ignition off. After clearing the DTC's, turn the ignition off, open and close the driver's door to disable RAP and leave the ignition off for at least 2 minutes. Remember, all controller specific instructions must be followed after completing both the SPS "Programming" and SPS "Configuration" functions.
