Service Bulletin

Bulletin No.: 18-NA-102

Multiple Electrical Concerns, Intermittent Multiple Instrument Panel Cluster (IPC) Warning Lamps Illuminated, Intermittent Multiple Message on Drivers Information Center (DIC), Intermittent and/or Inoperative Loss of Interior and Exterior Lighting, Engine Performance Concerns, Stalling, Transmission Shift Performance Concerns, Malfunction Indicator Lamp (MIL) Illuminated

Brand:	Model:	Model Year:		VIN:		Engine:	Transmission:
		from	to	from	to		
Chevrolet	Express	2003	2017				
GMC	Savanna

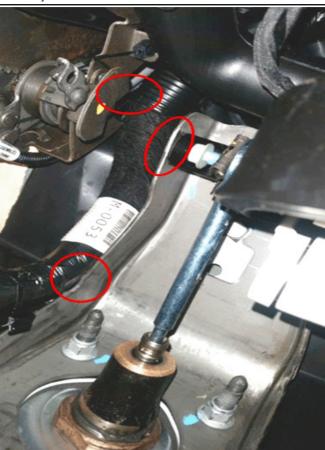
5031150

This condition may be caused by the main Instrument Panel (IP) wiring harness contacting one or more of the following:

- 1. With a suitable light, inspect the IP wiring harness point of contact.
- 2. Repair the harness as needed.
- ⇒ Refer to Wire to Wire Repair Instrument Panel and Console in SI.
- 3. Using Woven Polyester Electrical Tape (PET), tape all the contact points of the IP harness ensuring that the tape is applied in a double layer extending along the brake booster mounting bracket.
- ⇒ If required, replace the blow fuse in regards to repair performed on the IP harness.

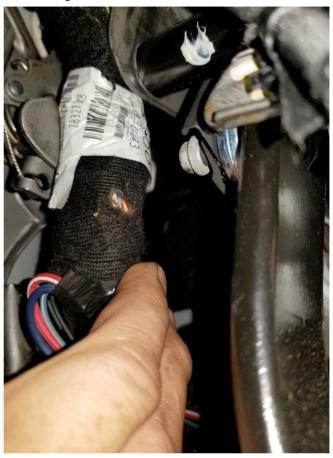
5035298

· Brake booster mounting bracket

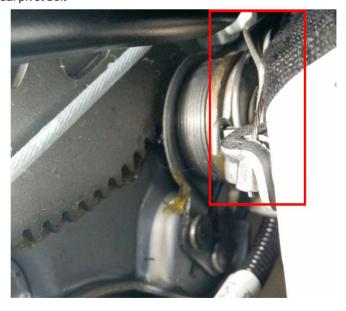
5035707

· Brake pedal pivot bolt

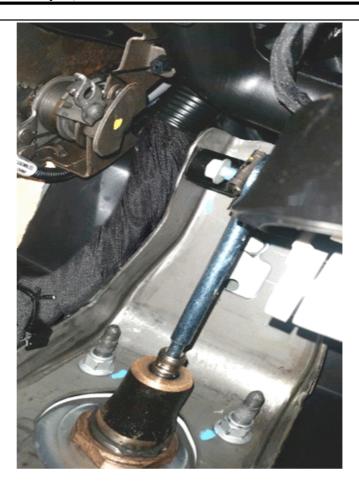
5033658

· Parking brake mechanism.
