Service Bulletin

Subject: Information on Gas Tank Crossmember Available as Service Part, Original Crossmember Rusted

Brand:	Model:	Model Year:		VIN:		Engine:	Transmission:
Branu.	woder.	from	to	from	to		
Chevrolet	Silverado HD	2007	2010		-	All	All
GMC	Sierra HD

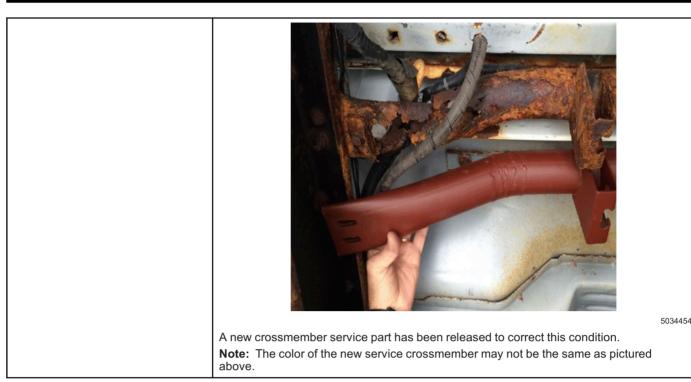
Involved Region or Country	North America			
Condition	Some customers may comment on finding rust or corrosion damage to the gas tank crossmember on the vehicle's frame.			
Cause	This may be caused by the vehicle being operated in an extremely corrosive environment or may have been exposed to corrosive materials, such as salt in the truck box.			
Correction	<image/> <image/>
