Service Bulletin

Bulletin No.: 18-NA-110

Subject: Recovery of Failed USB Radio Programming Event

Brand:	Model:	Model Year:		VIN:		Engine:	Transmission:
		from	to	from	to		
Cadillac	CTS	2017	2018			All	All
Cadillac	ATS XTS	2018	2018				
GMC	Terrain	2018	2018

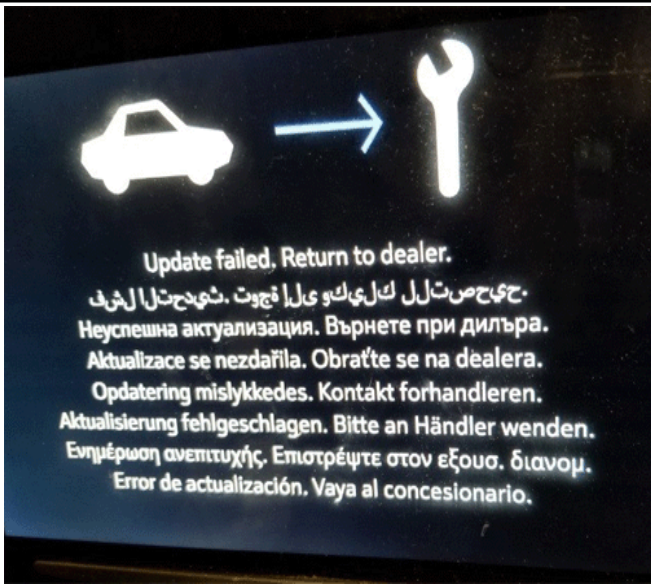
<p>5034832</p> <p>An error could occur during a USB radio programming event which causes the radio to display "Update failed. Return to dealer."</p>
Cause	There are several reasons such an error message could be displayed. These reasons typically fall into two categories; a problem with the USB thumb drive, or improper use/operation of a USB thumb drive.
Correction	<p>Important: Do NOT replace the radio for this error message without first utilizing the information that follows.</p> <p>Using the procedures and guidelines below can recover the radio and allow successful programming to complete.</p>

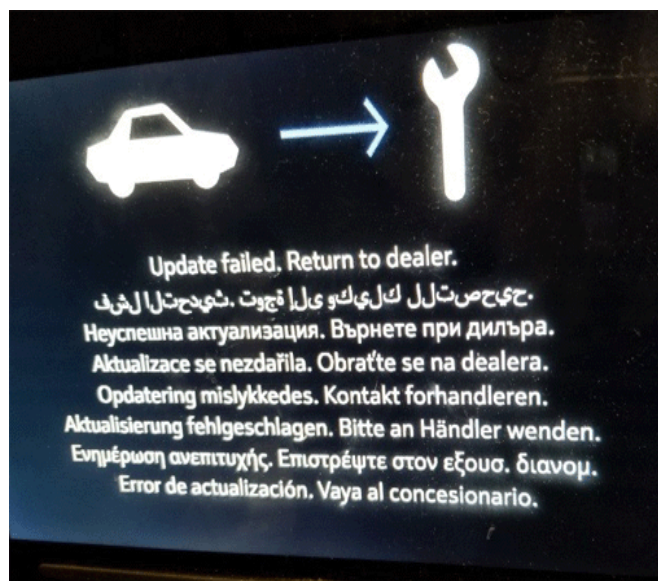
5034832

If the display is similar to that above, an error has occurred during the update process. Perform the procedure below to recover the radio.

1. Remove the USB thumb drive from the vehicle's USB port.
2. Turn Ignition on.

7. Delete all files from the USB thumb drive and download all needed files again, ensuring the proper ejection of the USB thumb drive.
8. With the ignition On, insert the USB with a new download of the update files. The update status bar should appear within 10 seconds and the update should start.
9. If after downloading the update contents, the update still does not start try a different brand of high-quality USB 3.0 thumb drive and repeat the programming steps again.
10. If after downloading the update again and using a new 3.0 USB thumb drive, the same image is displayed on the screen, replace the radio.
