Service Bulletin

Bulletin No.: 18-NA-113

Subject: Hard To Fill, Fuel Filling Station Nozzle Shuts Off Early and/or Spitback During Filling

Brand:	Model:	Model Year:		VIN:		Engine:	Transmission:
		from	to	from	to		
Buick	LaCrosse	2017	2018				
Chevrolet	Malibu

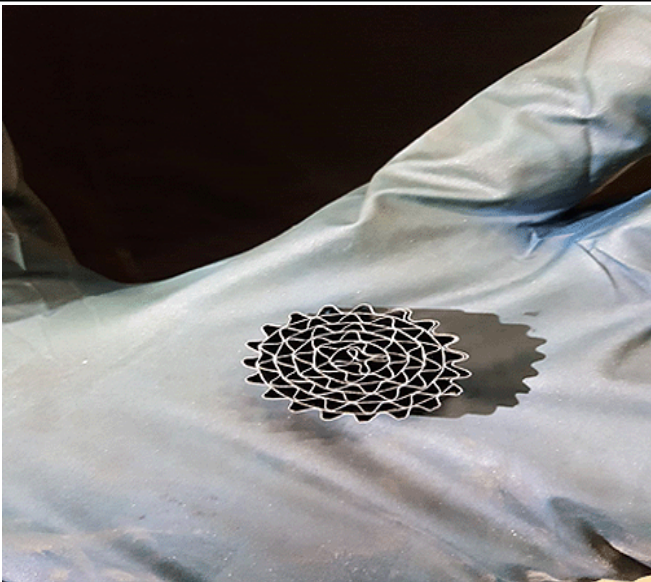
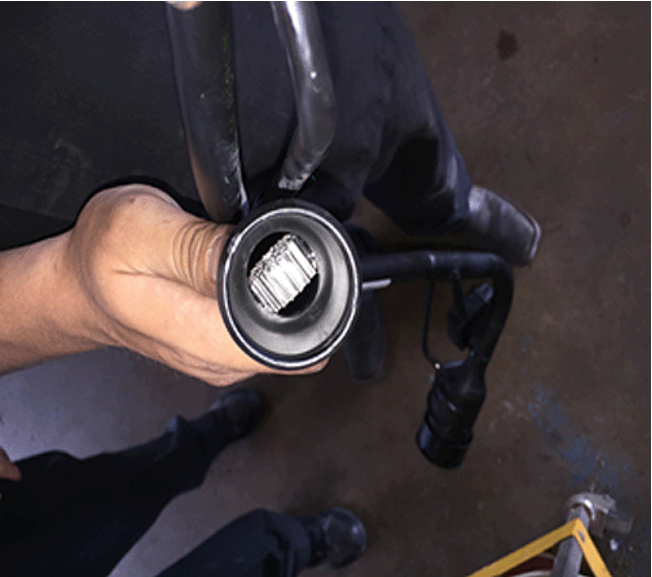
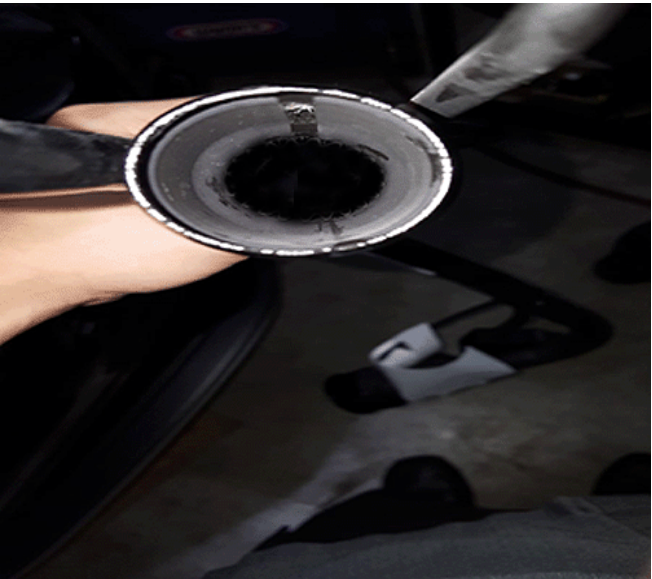
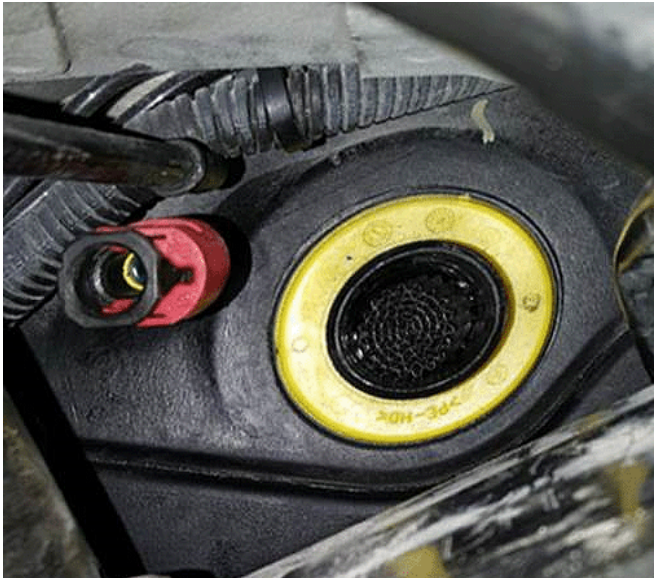
<p>5042143</p> <p>This condition may be caused by the vapor generation reduction device (VGRD) in the fuel pipe that may have become dislodged, moved out of position and/or stuck in the fuel tank inlet check valve, as shown above, and is restricting fuel flow.</p> <p>Note: This condition will occur regardless of how full the tank is.</p>
Correction

If a restriction is located in the fuel filler pipe, or the generation reduction device is out of position, replace the fuel filler tube. Refer to *Fuel Tank Filler Pipe Replacement* in SI.
