Service Bulletin

Bulletin No.: 18-NA-114

Subject: Malfunction Indicator Lamp (MIL) Illuminated - DTC P0641 Set

Brand:	Model:	Model Year:		VIN:		Engine:	Transmission:
		from	to	from	to		
Chevrolet	Trax	2018	2018			LFV

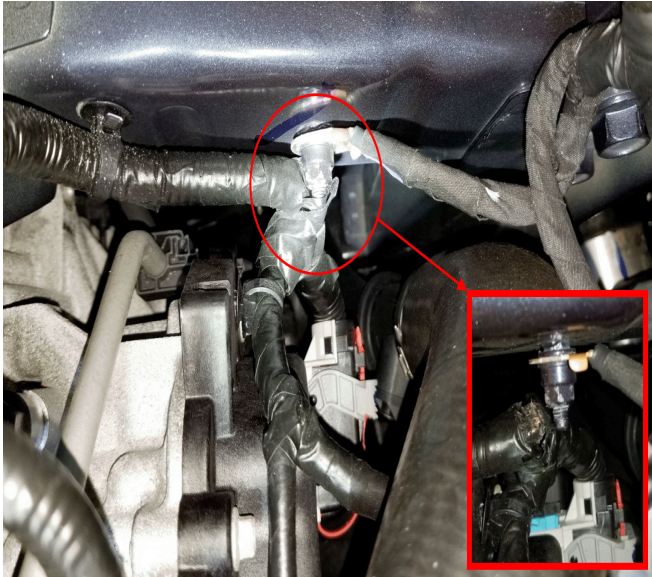
Correction	<div style="text-align: right; margin-bottom: 10px;">5040432</div>

Involved Region or Country	North America and Israel.
Condition	<p>Note: Not all of the effects or driver notifications listed have been experienced. However, the different effects and driver notifications may be caused by one of the wires in the wiring harness being chafed or cut. Components on different lines in the list below are in different circuits. Due to the cause of the condition, and the positions of the wires in the harness, it is unlikely that more than one circuit and/or fuse will be affected by the condition.</p> <p>Some customers may comment that the MIL is illuminated.</p> <p>The technician may find DTC P0641 (5V Reference 1 Circuit) set in the Engine Control Module (ECM).</p>
Cause	<p>Note: This is a multi-wire bundled harness and, depending on which wire is damaged, can set a variety of DTCs.</p> <p>This condition may be caused by the engine harness chaffing against the G100 Ground stud.</p>

<p>If the above condition has been validated, inspection of the engine wiring harness must be done.</p> <ol style="list-style-type: none"> 1. With a suitable light, inspect the wiring harness point of contact at the G100 ground stud. <p>⇒ For stud location, refer to Document ID: 4708510 in SI.</p> <ol style="list-style-type: none"> 2. Repair the harness as needed. <p>⇒ Refer to Wire to Wire Repair in SI.</p>
