Service Bulletin

Bulletin No.: 18-NA-115

Subject: Cold Start Misfire and/or Rough Idle – DTC P0300 May Be Set

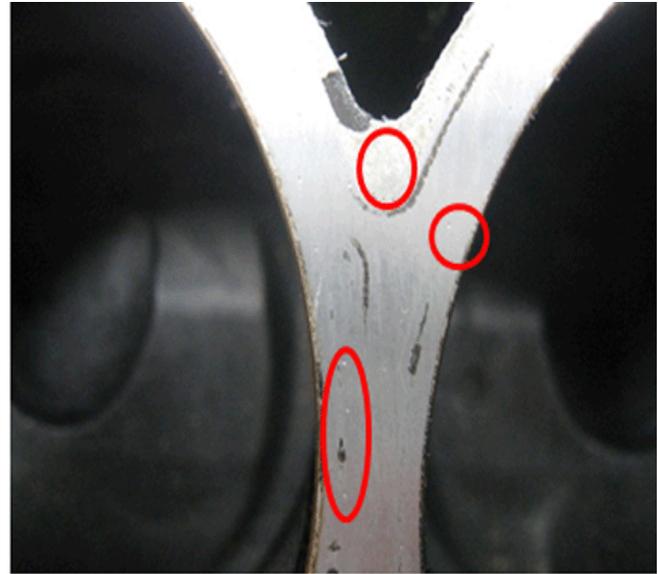
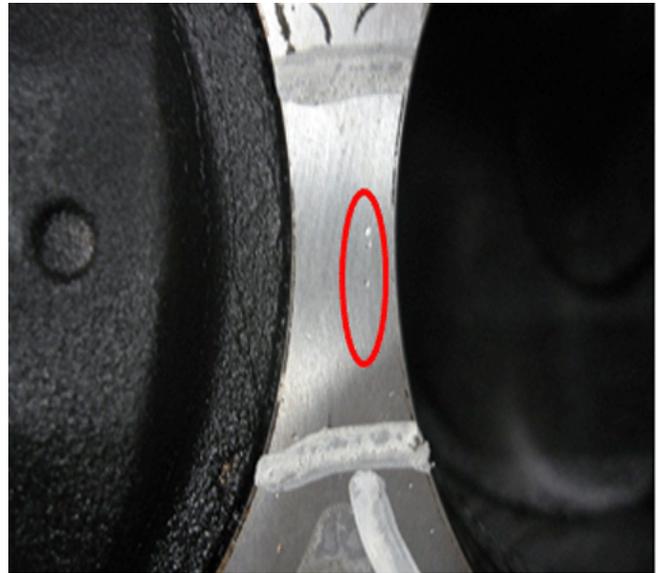
Notice: Small surface pock marks or pitting appearance on the deck surface is normal and an engine should not be replaced for any such appearance marks as they do not connect to the engine coolant passages and cause a leak path that will generate engine misfires.

6. With the cylinder head removed, perform a visual inspection. Reference the following pictures provided. The first two pictures represent normal examples of deck pitting and **are not** the cause of the misfire and/or rough idle condition.

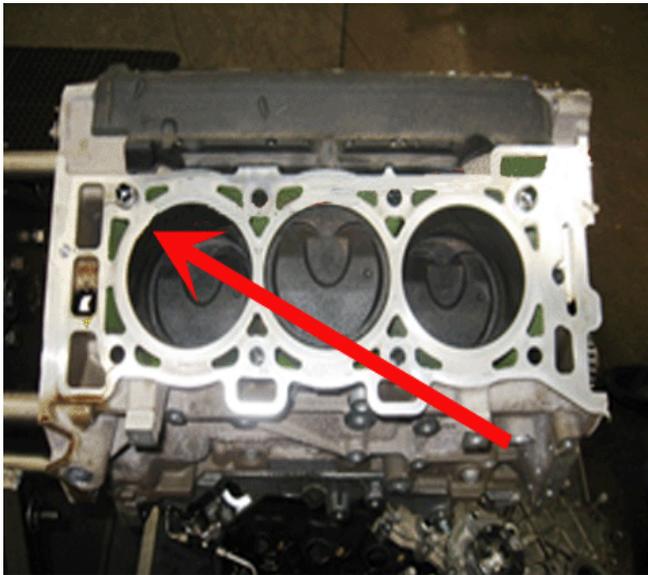
3632865

| Cause | Possible engine cylinder block porosity causing a pinhole at the liner to deck face casting area, allowing engine coolant to leak into the affected cylinder. The technician may observe on a scan tool DTC P0300 Engine Misfire Detected set in the K20 Engine Control Module. |

7. The two following pictures represent an example and the location of how actual engine cylinder block porosity appears. This would be a cause of the condition.

Shown at the deck face to cylinder liner interface location is an area of engine cylinder block porosity that has caused an engine coolant leak path into the cylinder causing medium to high misfire counts when the engine is cold.

⇒ If this condition is verified, the engine **must** be replaced.
