# Service Bulletin

Bulletin No.: 18-NA-116

**Subject:** Install API Manager Message Displayed After Radio Replacement

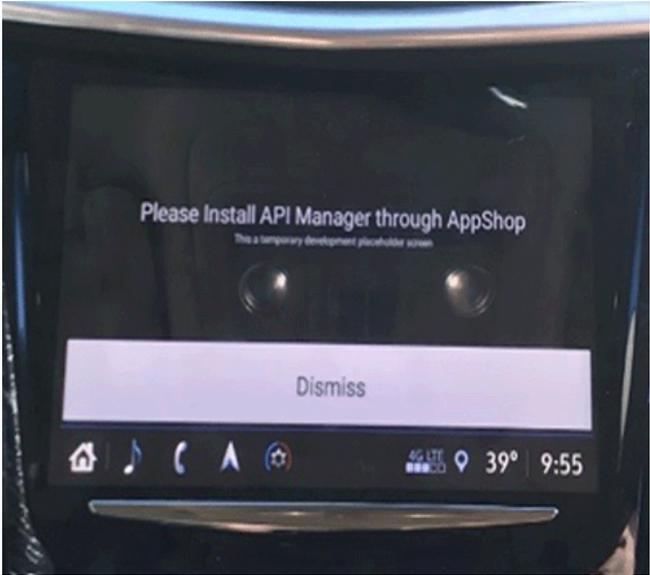
<p style="text-align: right;">5041591</p> <p>Some customers/technicians may comment on the radio displaying the message "Please Install API Manager through AppShop" when downloading or launching an app after radio replacement.</p>
<b>Cause</b>	This message could occur if the Radio Reset procedure was not followed in SI prior to removal of the radio.
<b>Correction</b>	Reinstall the previously removed radio then perform the radio reset.

If you encounter a vehicle with the above concern, reinstall the previously removed radio then perform the radio reset. Refer to *Radio Reset* in SI. If the condition persists, delete the app and download it again.
