Bulletin No.: PI0564J

Service Bulletin

Subject: Wax Coating on Frame Peeling, Metal Shows Corrosion/Rusting (U.S. and Canada Only)

Models: 2011-2018 Cadillac Escalade Models
2011-2013 Chevrolet Avalanche
2011-2018 Chevrolet Express, Silverado, Suburban, Tahoe
2011-2018 GMC Savana, Sierra Models, Yukon Models

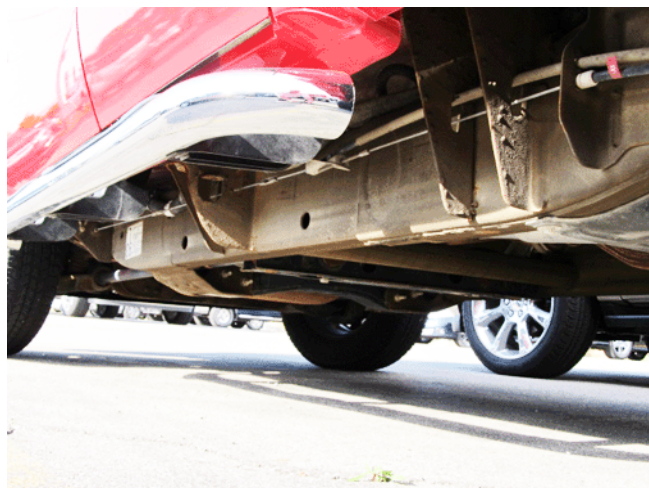
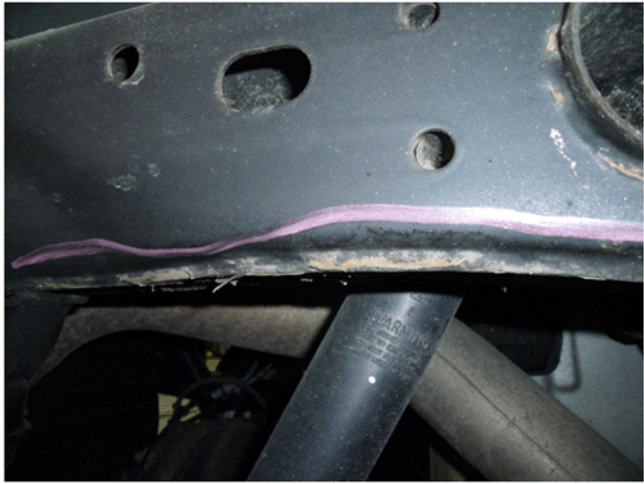
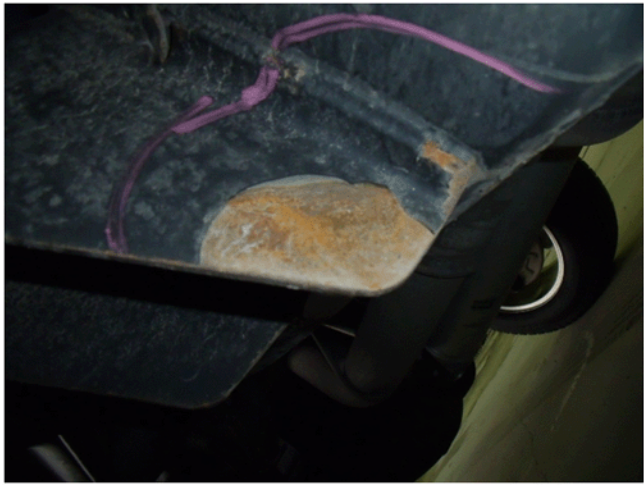
Truck Example Photos

Some customers may comment that areas of the frame wax coating are peeling off and rust/corrosion is visible on the metal in these areas. Several examples of this condition are shown in each group of graphics below.

A combination of specialized metal coating products manufactured by Lloyds and Daubert have been found to be the most suitable products to provide corrosion control and protection to address this type of repair. Our recommendation is to prep the metal surface using *Lloyd's Pure Prep™ Metal Surface Preparation P/N 25418, then topcoat with both *Lloyds Kryptonite Metal Treatment P/N 36502 Life Long Rust Protection and *Daubert Non-Rust® P/N X-121B One Coat Rust Preventative Coating. It is strongly recommended they be applied according to the manufacturer's procedures.
