Service Bulletin

PRELIMINARY INFORMATION

Subject: Rear and Side Tempered Glass Spots (Quench Marks)

Models: 2019 and Prior GM Passenger Cars and Trucks

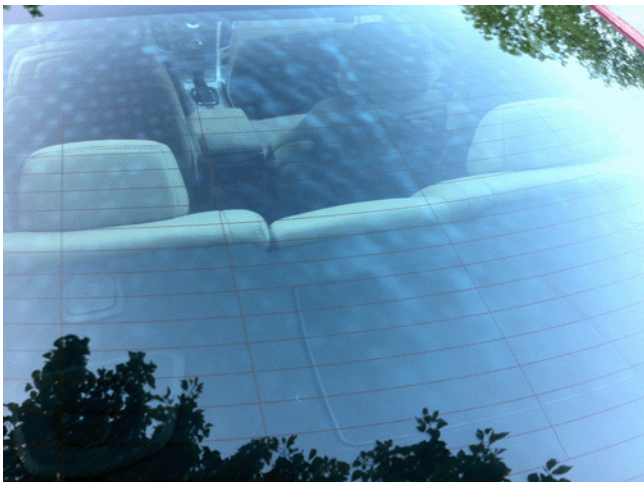
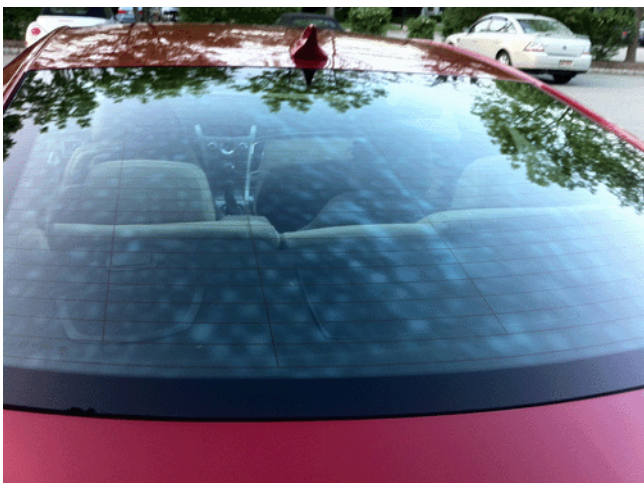
Some customers may comment on spots showing on the rear and side windows when the vehicle is in the sunlight. When wearing polarized glasses/sunglasses, these spots may be more magnified.

The spots are due to the manufacturing process and are “quench marks” in the glass. Quench marks are an unintentional side effect of the

tempering process.

Technicians should explain to the customer that this is a normal condition and part of the manufacturing process for tempered glass. Do not replace the window(s) for this condition.
