Service Bulletin

Bulletin No.: 18-NA-056

Subject: Drivers Side Object Sensing Alert Module Not Working Correctly and/or Incorrect Side Mirror Notification

Brand:	Model:	Model Year:		VIN:		Engine:	Transmission:
		from	to	from	to		
Buick	Encore	2017	2018

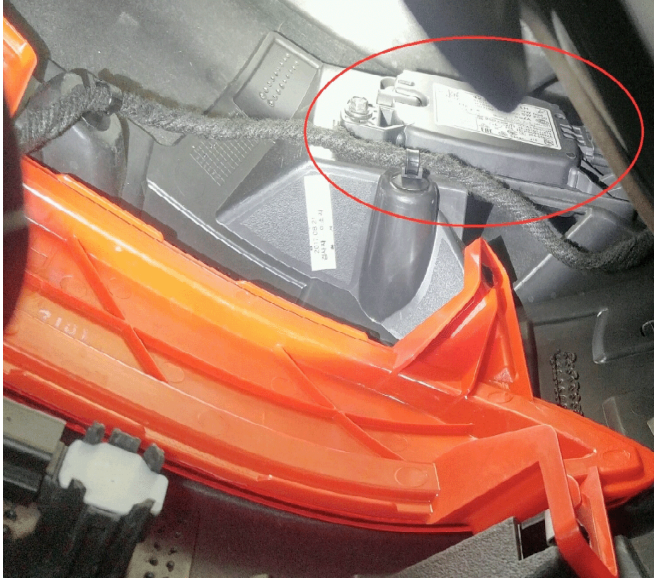
Involved Region or Country	North America
Additional Options (RPOs)	Equipped with SIDE ACTIVE SAFETY-OBSTACLE DETECTION (RPO UFT)
Condition	Some customers may comment when driving, the side mirror indicates there is a vehicle present when there is not.
Cause

<p style="text-align: right;">4974639</p> <p>Note: Most radar reflections may be found worse on the driver side than the passenger side.</p> <p>This condition may be caused by unwanted radar reflection being detected and triggering the false alerts.</p>
Correction	If the side blind zone has been found not working properly, apply a piece of aluminum butyl tape to the bottom of the drivers side object sensing alert module.
