# Service Bulletin

Bulletin No.: 18-NA-128

**Subject:** Hood Vent Paint Chipping and/or Peeling

Brand:	Model:	Model Year:		VIN:		Engine:	Transmission:
		from	to	from	to		
Cadillac	CTS-V	2016	2018	SOP	November 1, 2017	LT4	All

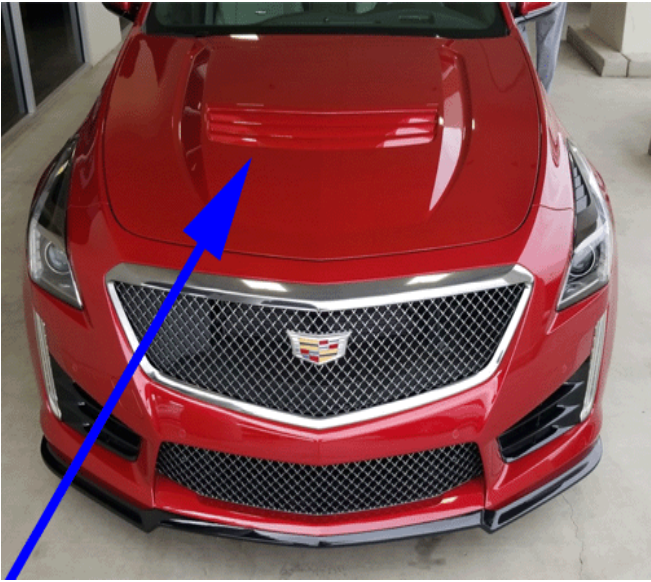
5044040

<p data-bbox="1419 739 1484 758">5044041</p> <p data-bbox="537 768 1471 821">Some customers may comment on the paint chipping or peeling on the outer perimeter of the hood vent.</p>
<p data-bbox="131 1150 204 1178"><b>Cause</b></p>

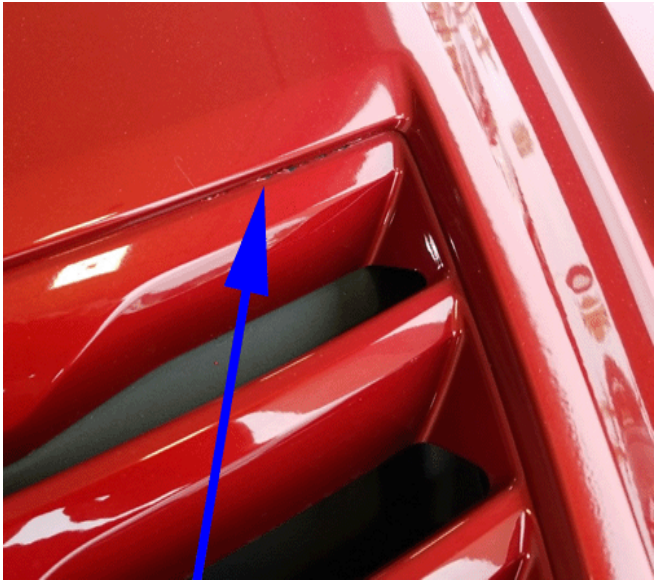
<p data-bbox="1419 1413 1484 1432">5044043</p> <p data-bbox="537 1444 1422 1497">This may be due to a tight tolerance between the underside of the hood and the vent assembly.</p>
<p data-bbox="131 1507 253 1535"><b>Correction</b></p>	<p data-bbox="537 1507 1235 1535">Remove the vent, refinish and reinstall with the addition of shim kit.</p>
