# SERVICE BULLETIN

Classification: EC16-026b	Reference: NTB16-086b	Date: April 19, 2018
------------------------------	--------------------------	-------------------------

## 2013-2014 SENTRA; ENGINE TURNS OFF OR HESITATES WHEN ACCELERATING FROM A STOP DURING HOT AMBIENT TEMPERATURES (100° F OR MORE)

**APPLIED VEHICLES:** 2013-2014 Sentra (B17)

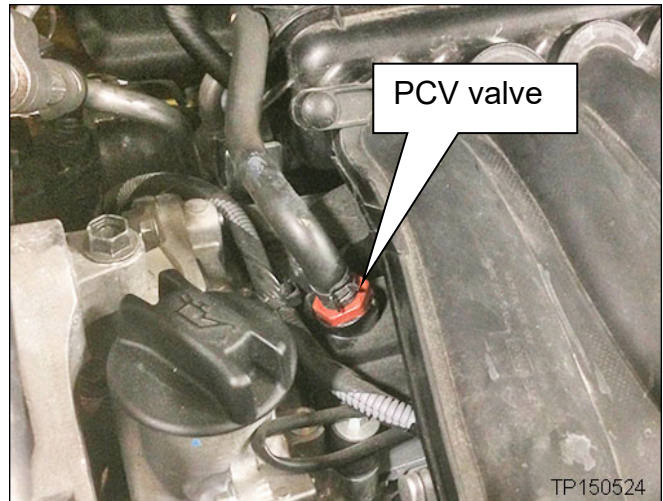
1. Inspect the color of the PCV valve, and replace if the color is orange (see Figure A on page 2).
2. Refer to step 6 in the Reprogram ECM section of the SERVICE PROCEDURE to confirm if reprogramming is needed.
3. If needed, perform ECM reprogram.

#### **If the PCV valve is orange, as shown in Figure A:**

- Replace the PCV valve.
- If needed, refer to the Electronic Service Manual (ESM), section EM-Engine Mechanical, for replacement information.
- Use the new PCV valve listed in the Parts Information.
- The new PCV valve is “black” color.
